**ENVIRONMENTAL PROTECTION AGENCY
MEETING**

**REGION 2 HEADQUARTERS
NEW YORK, NY**

DECEMBER 19, 2019

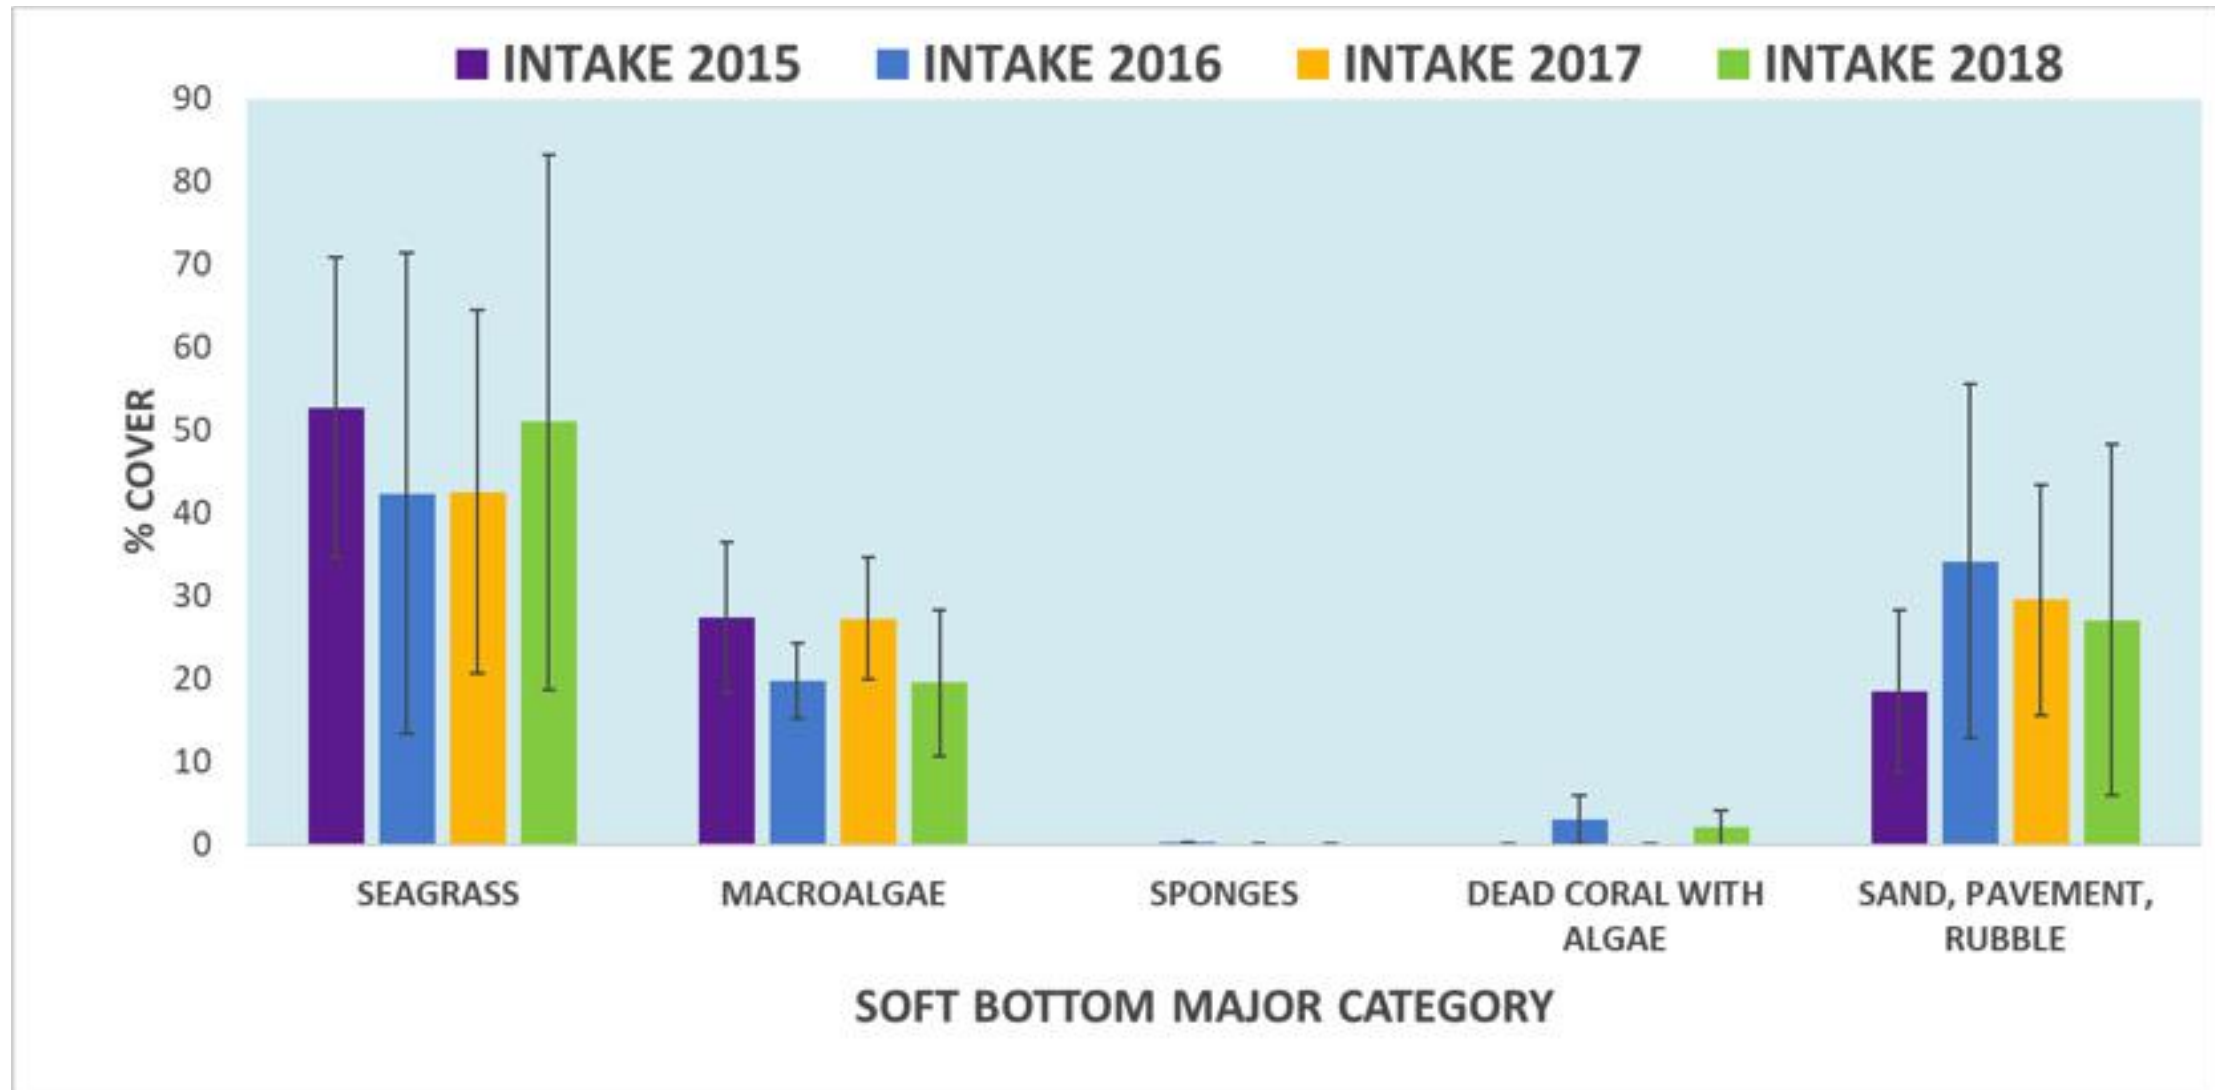
Seagrass Transect Monitoring at the Intake Station

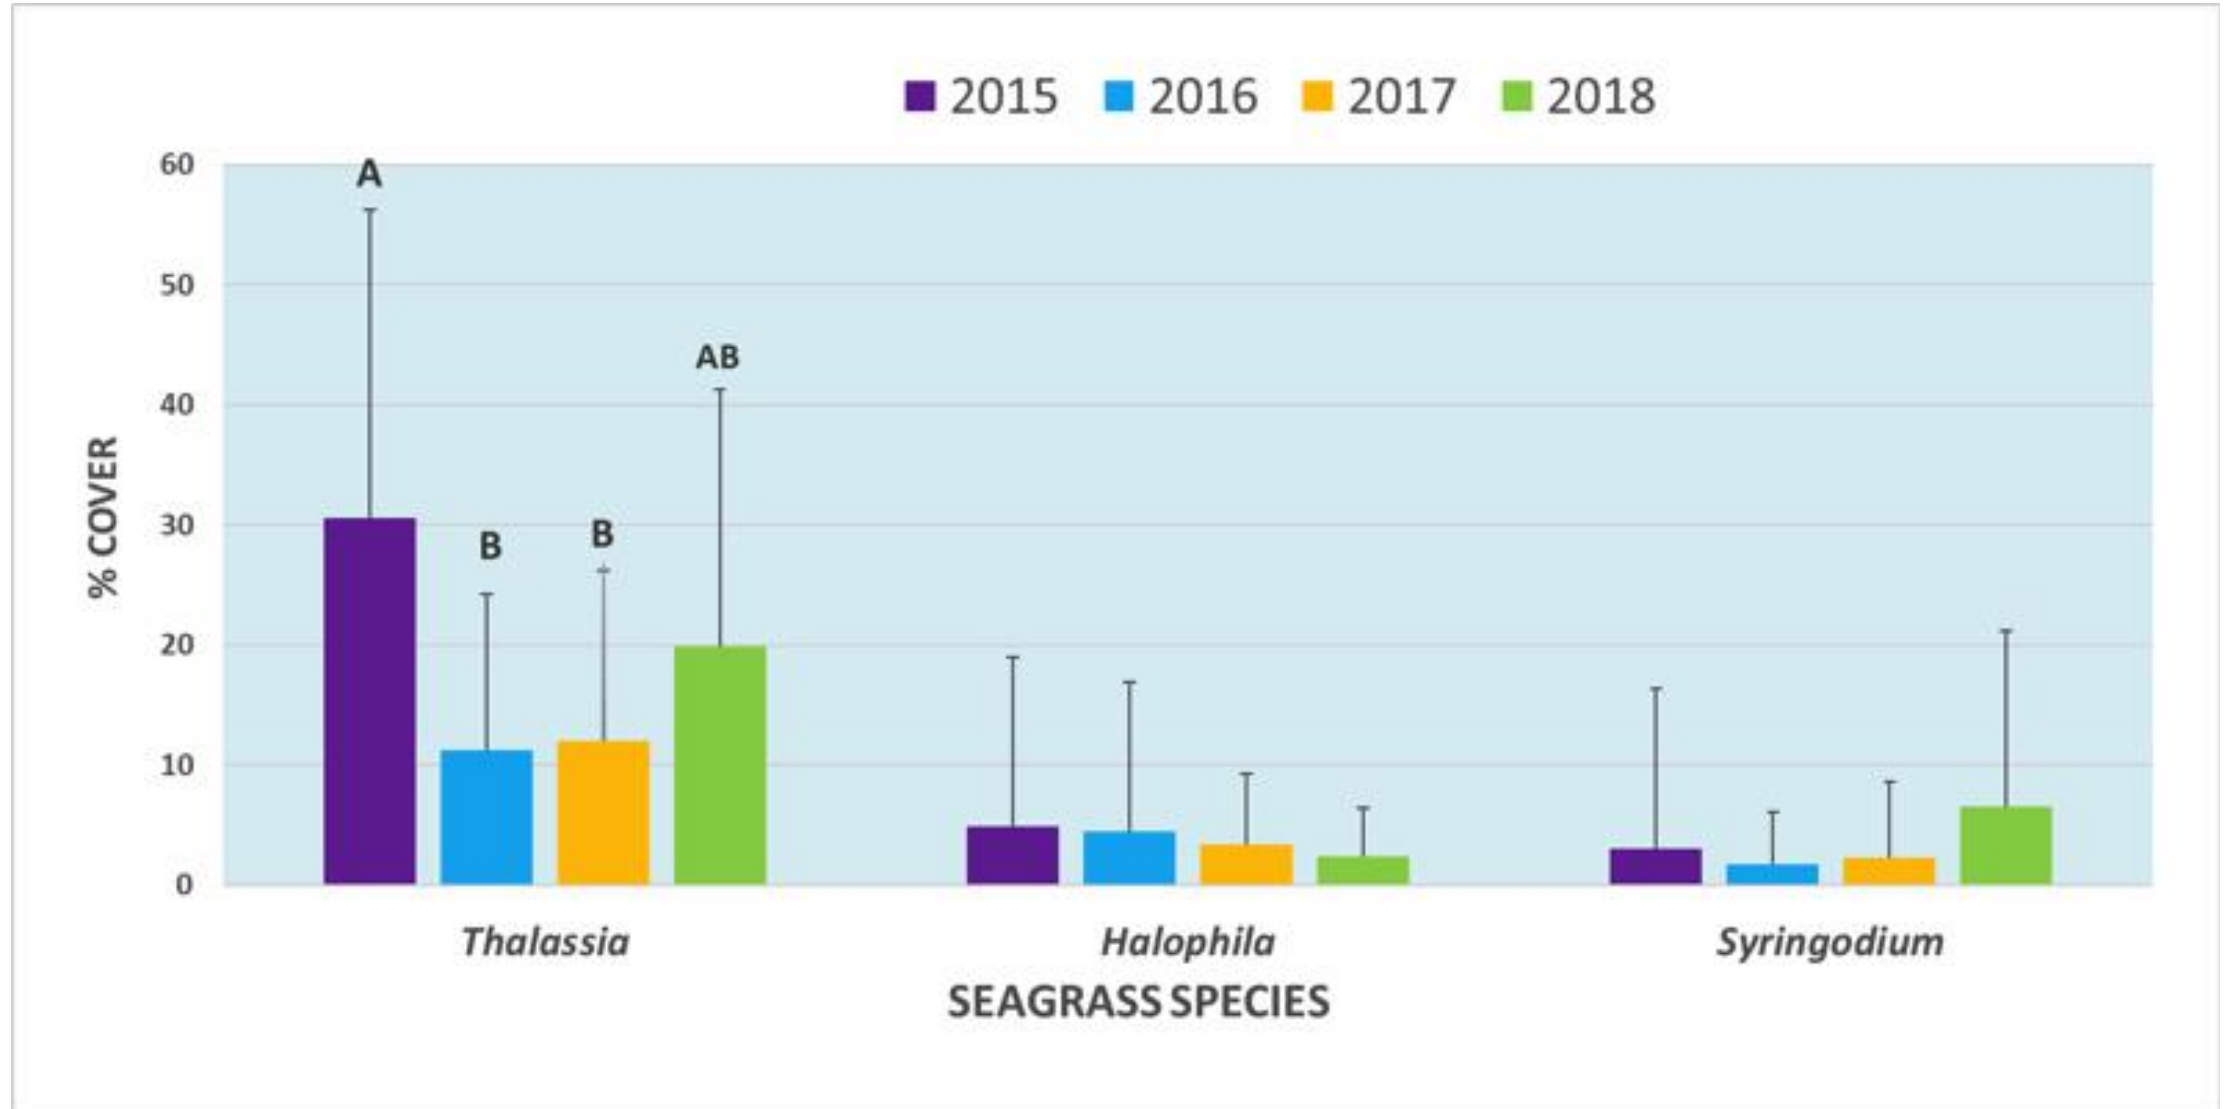
Seagrass Cover by Species at the Discharge Station

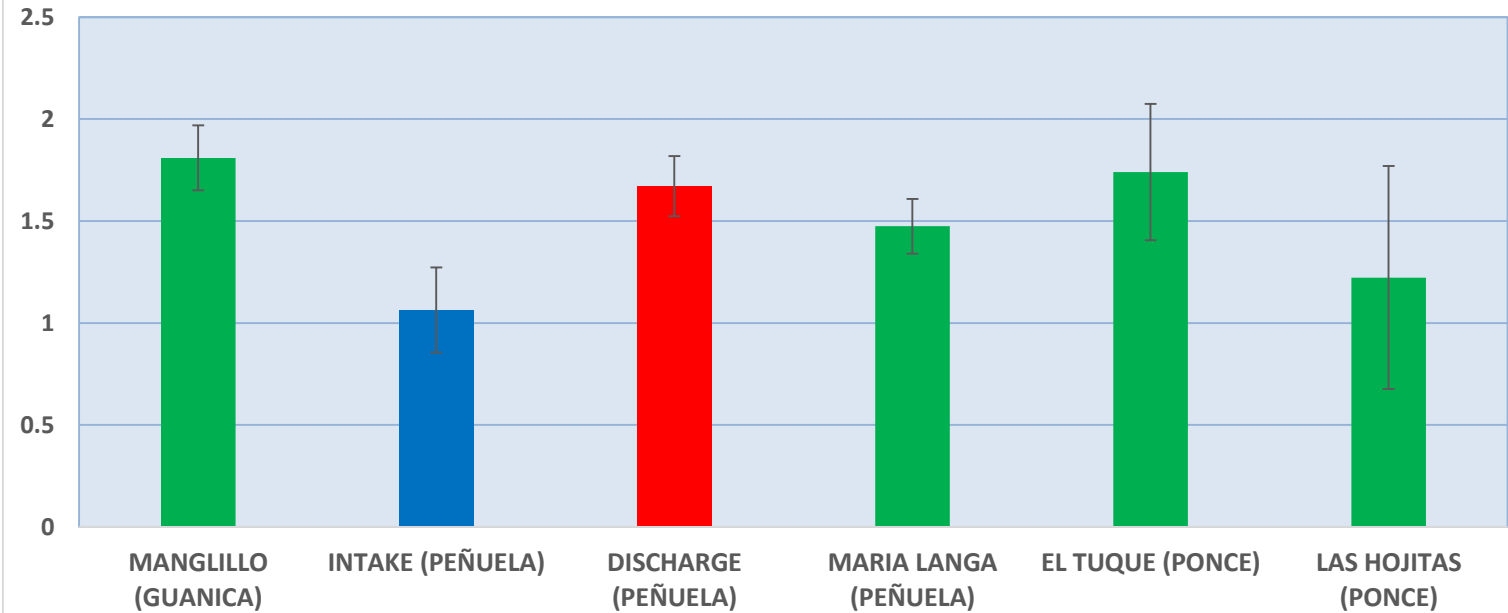
ACCUMULATIVE LINEAR BLADE GROWTH (cm/day)
