ENVIRONMENTAL PROTECTION AGENCY MEETING  
ECOELÉCTRICA BIOLOGICAL MONITORING PROGRAM  
REGION 2 HEADQUARTERS, NY  
MAY 22, 2024

## EcoEléctrica Biological Monitoring Program Plan (BMPP) 2019-2024 Update

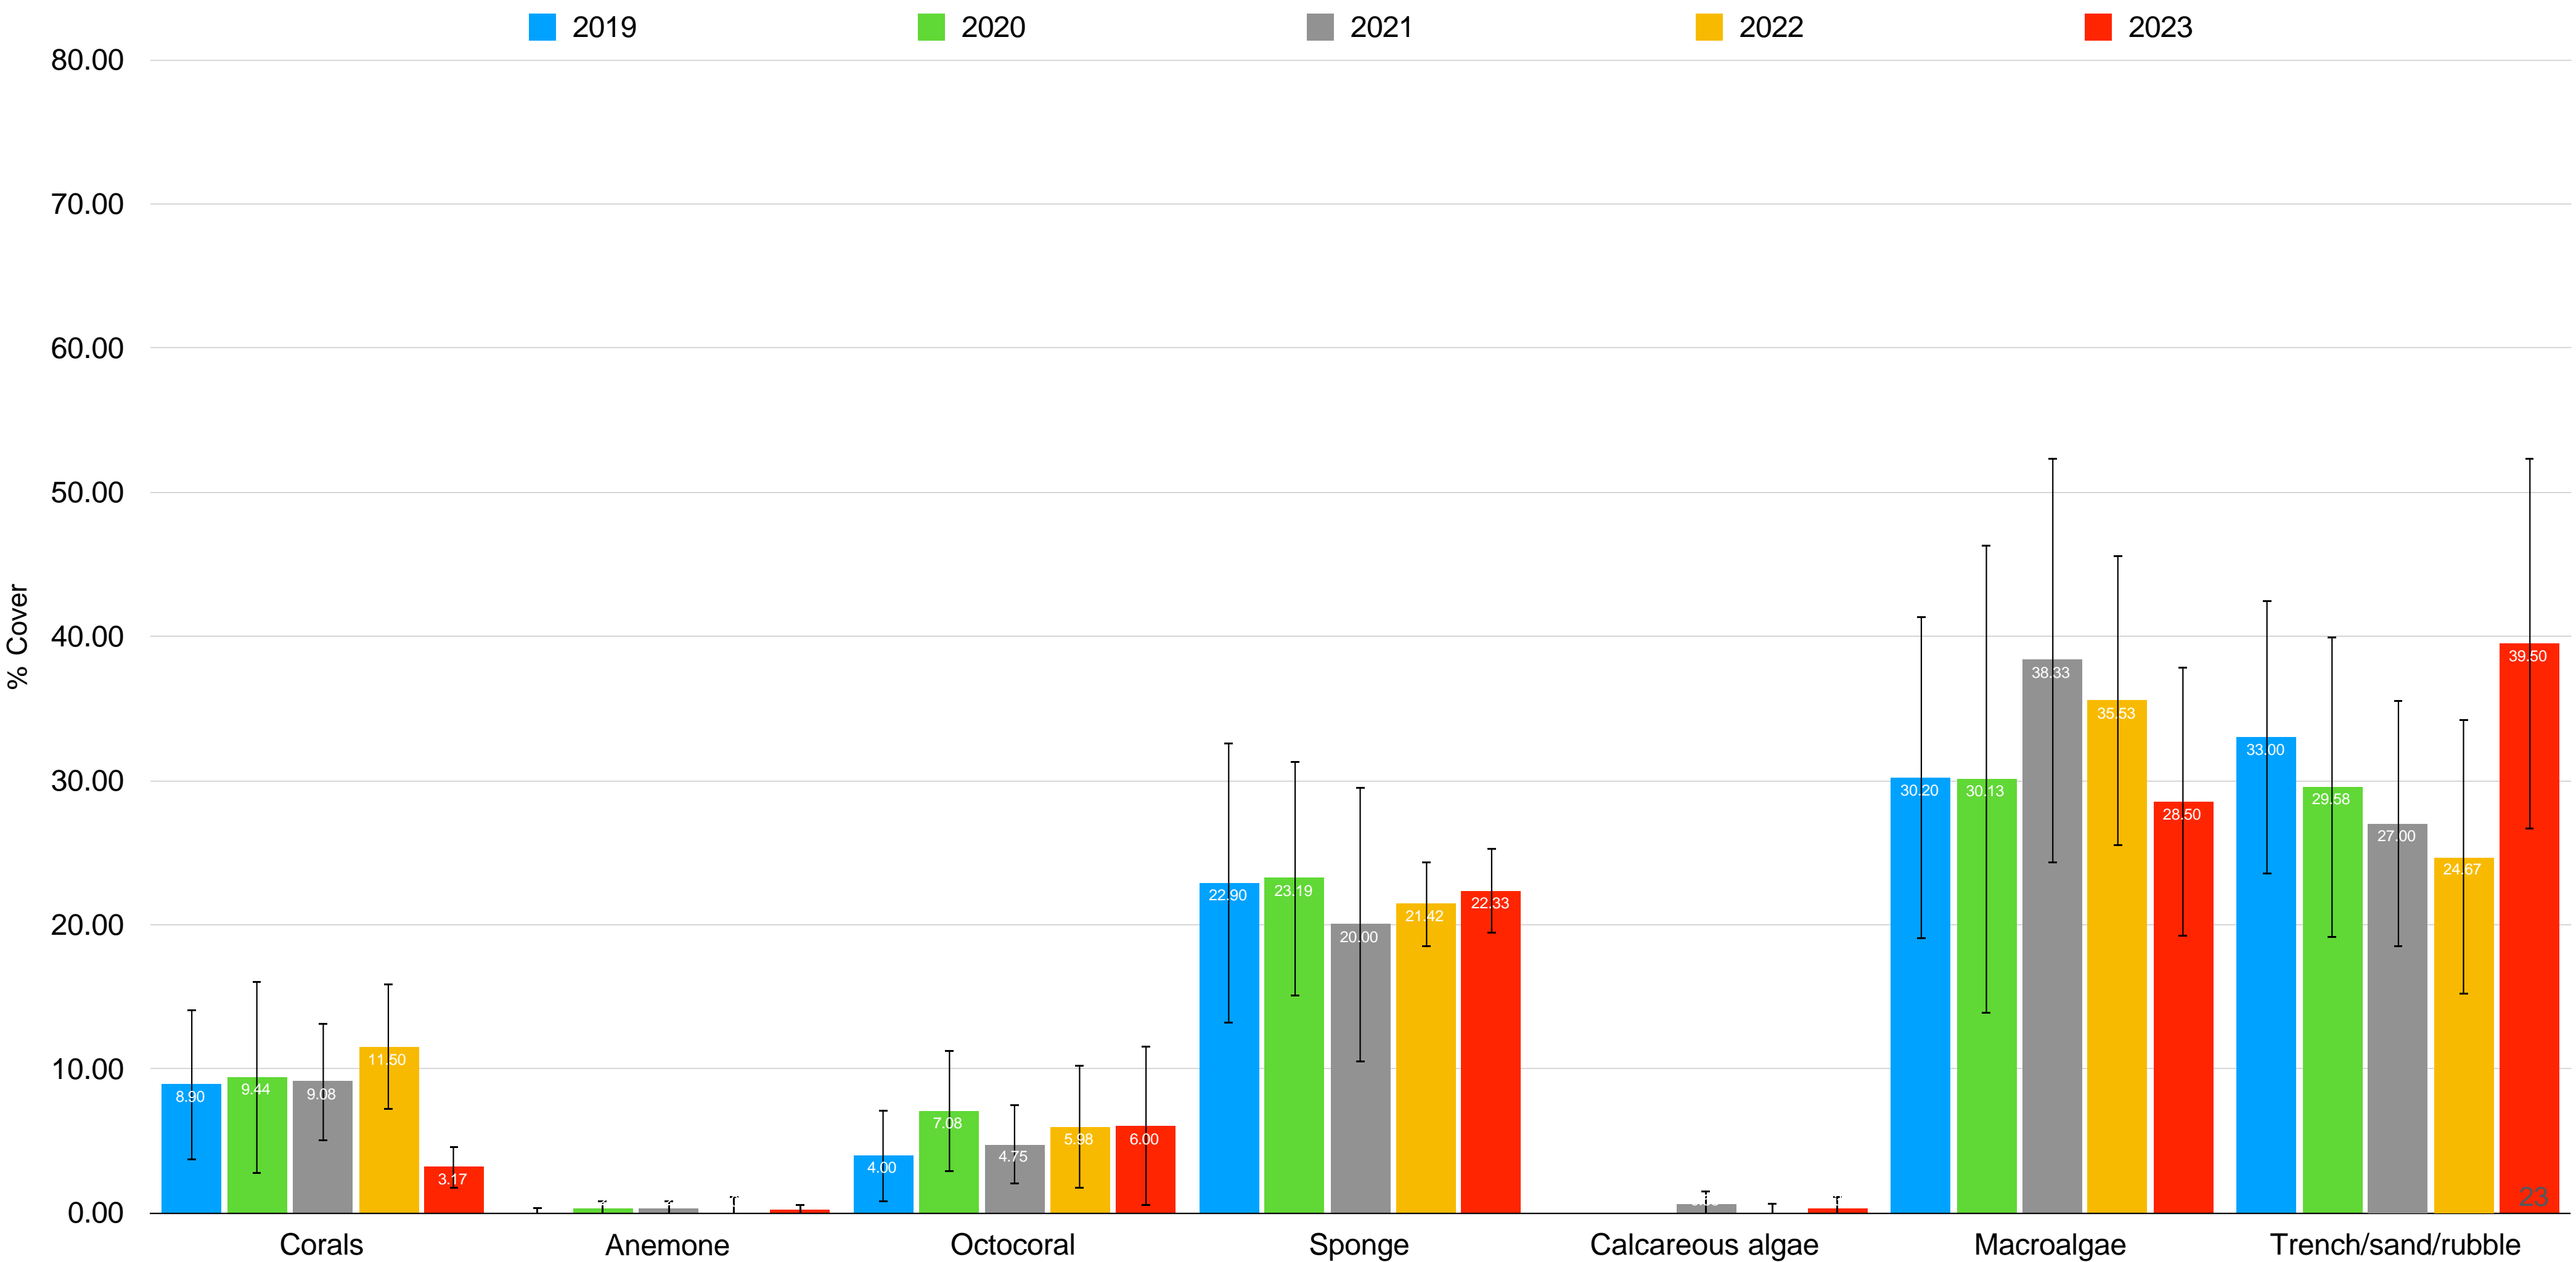
# Discharge station mean linear percent cover

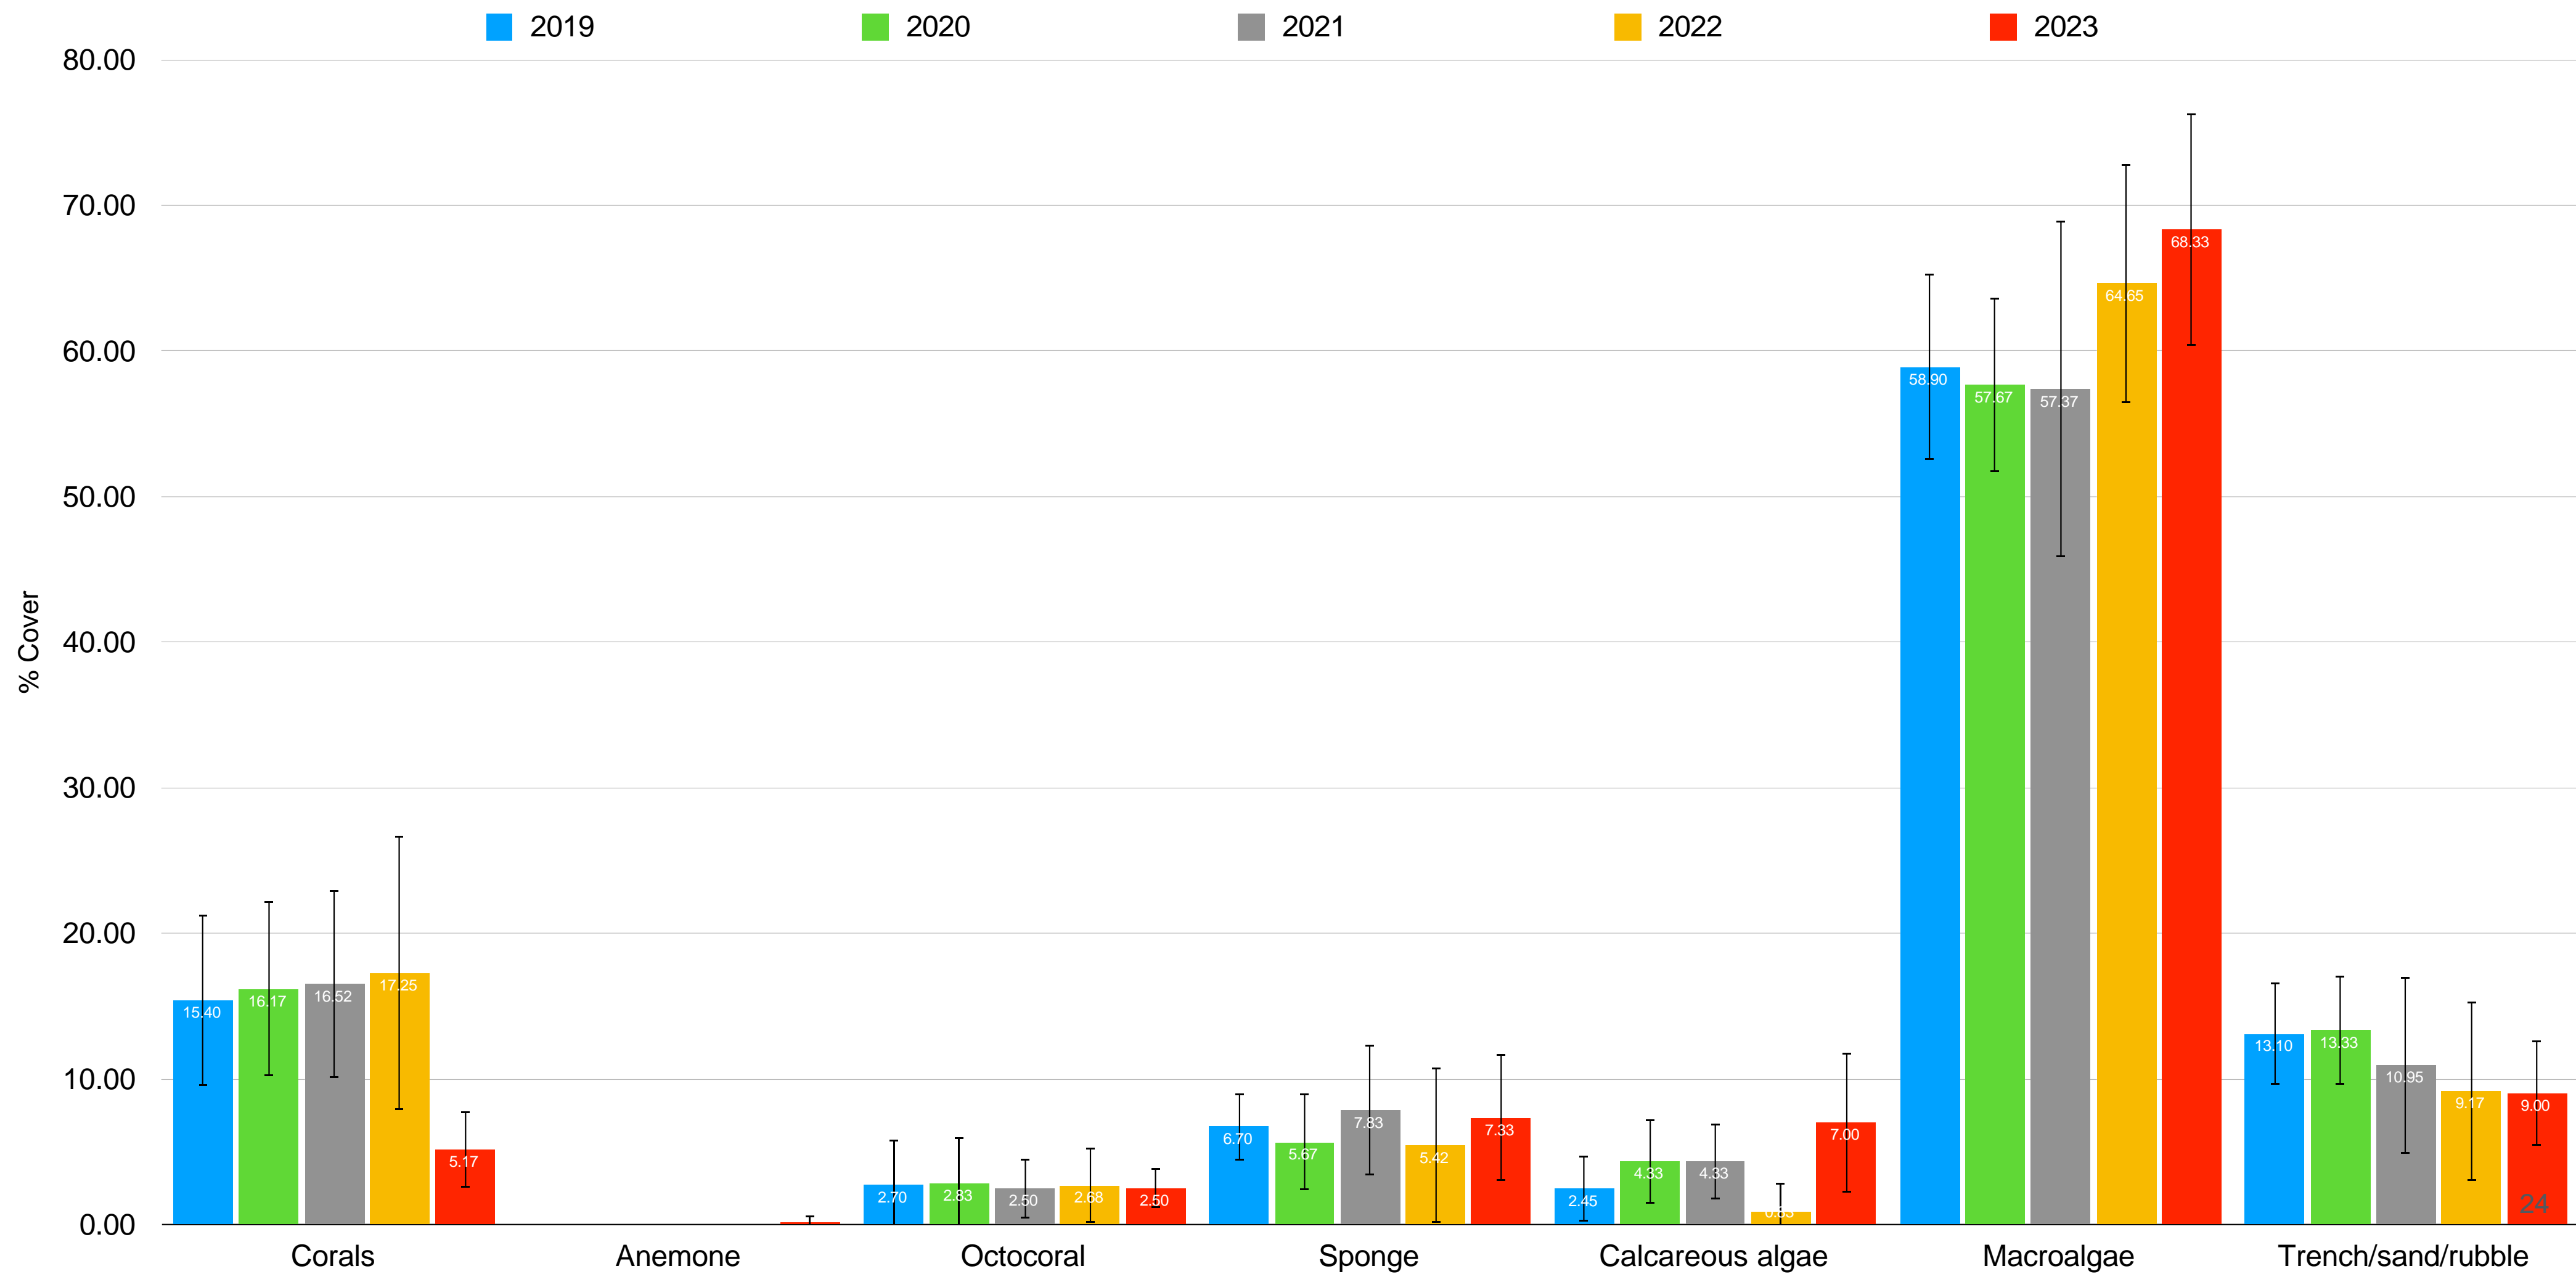
# Intake station mean linear percent cover

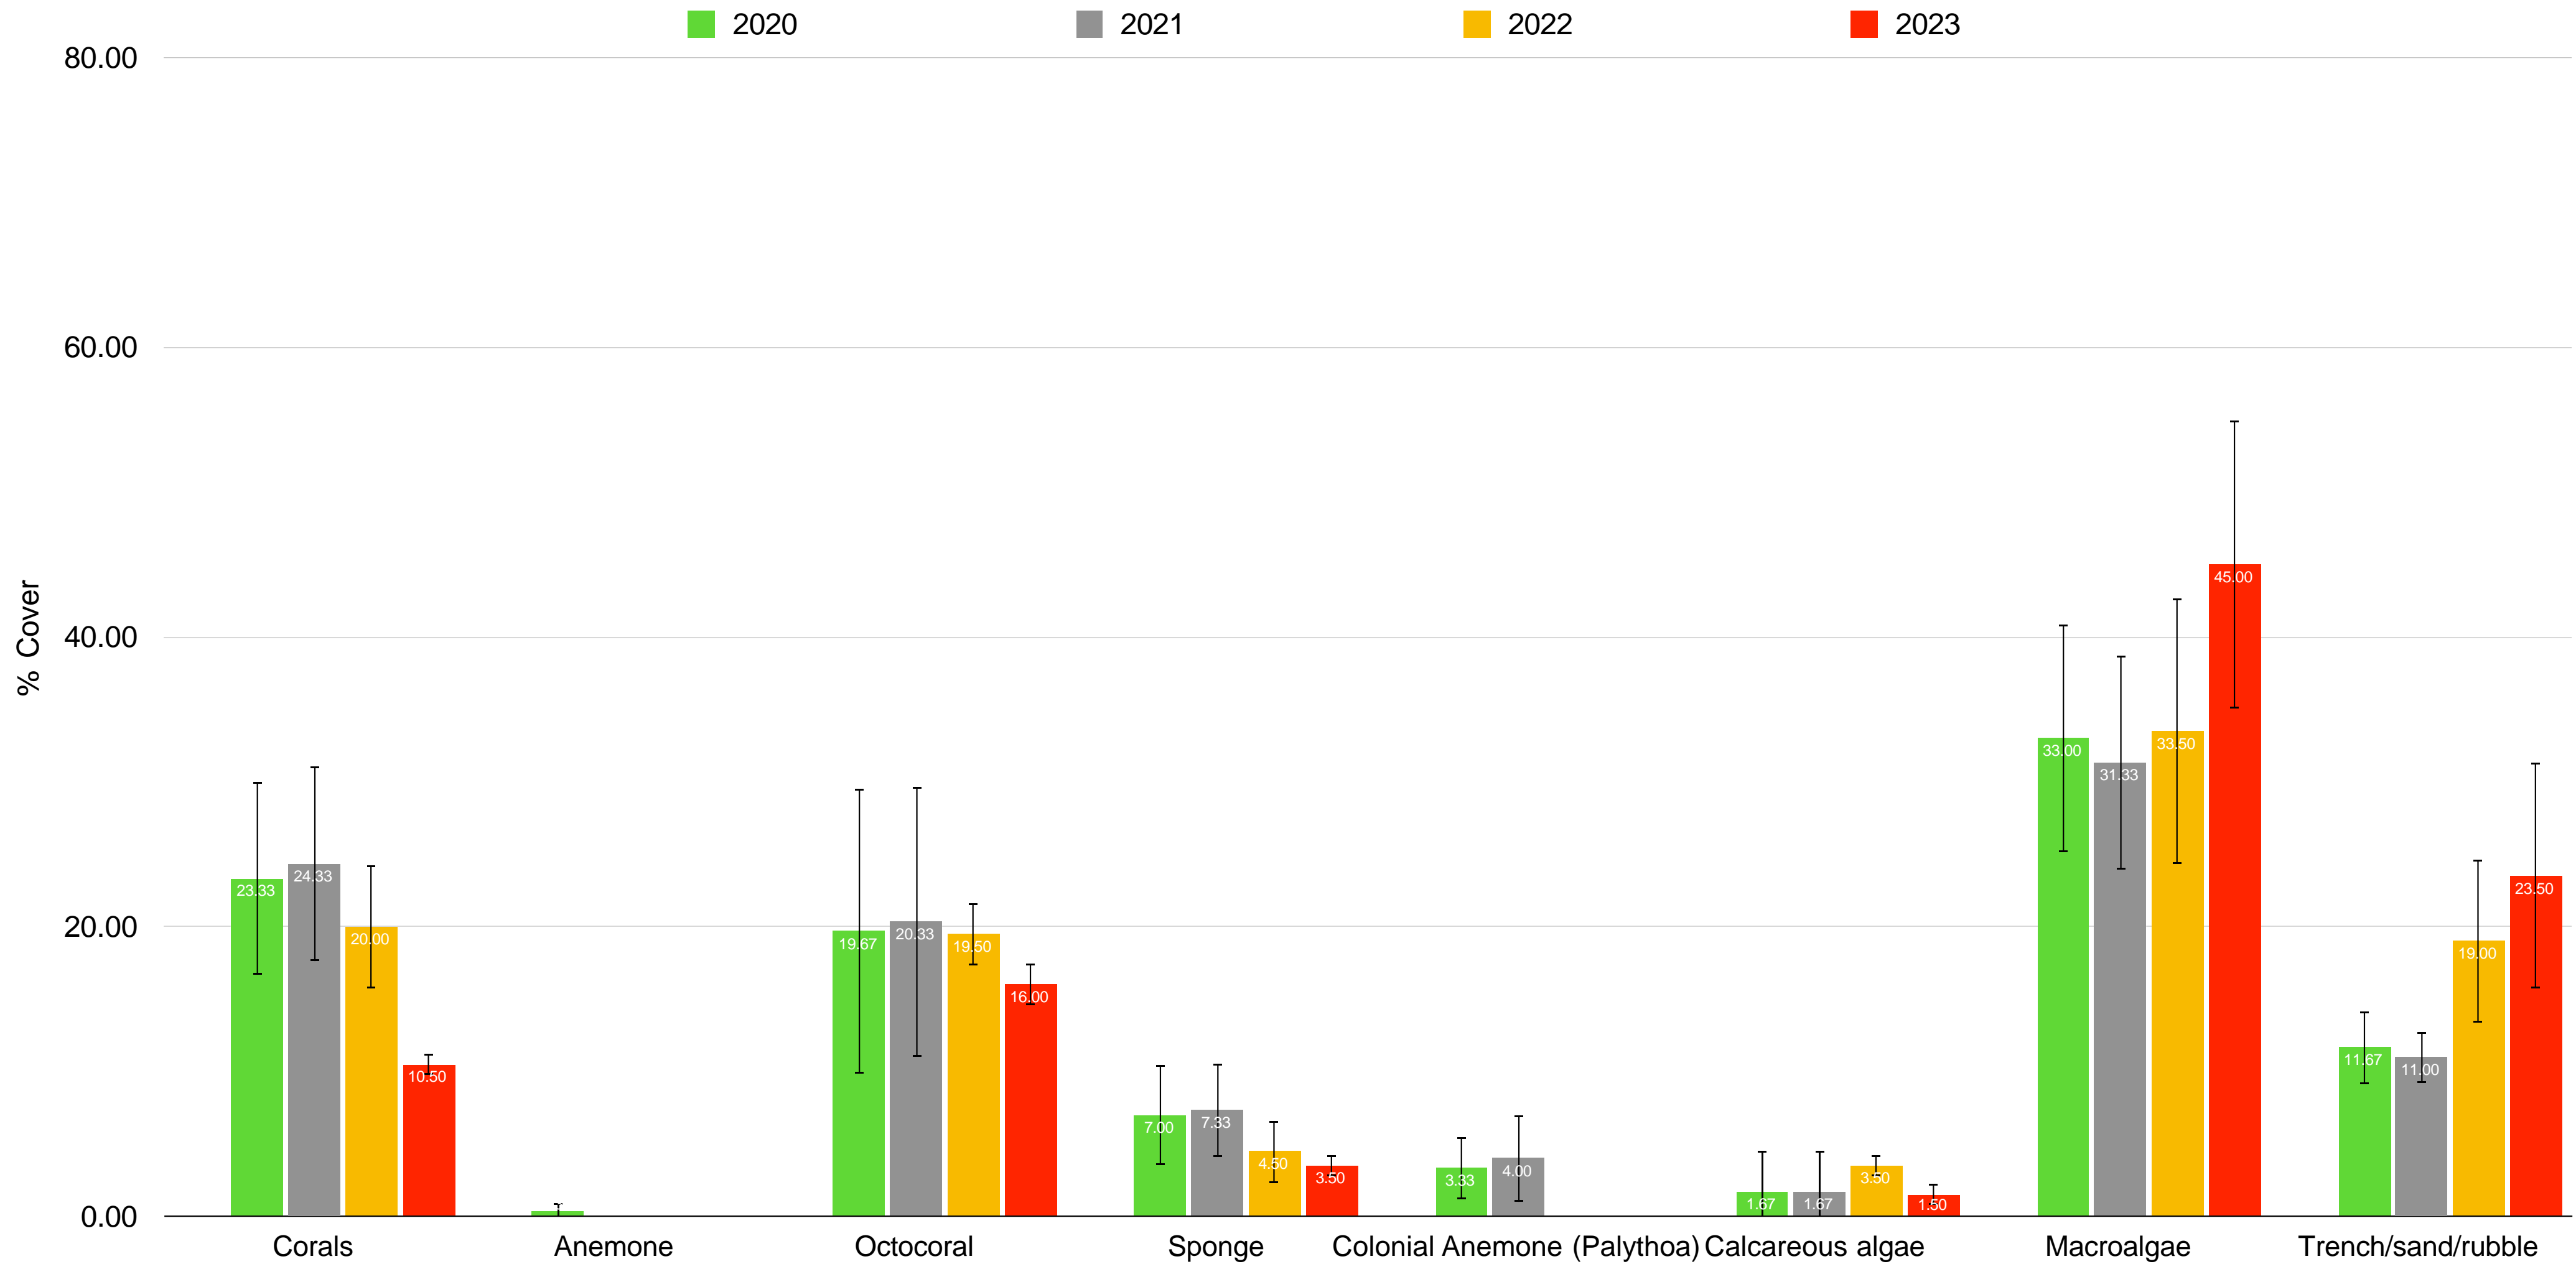
# Luis reef station mean linear percent cover

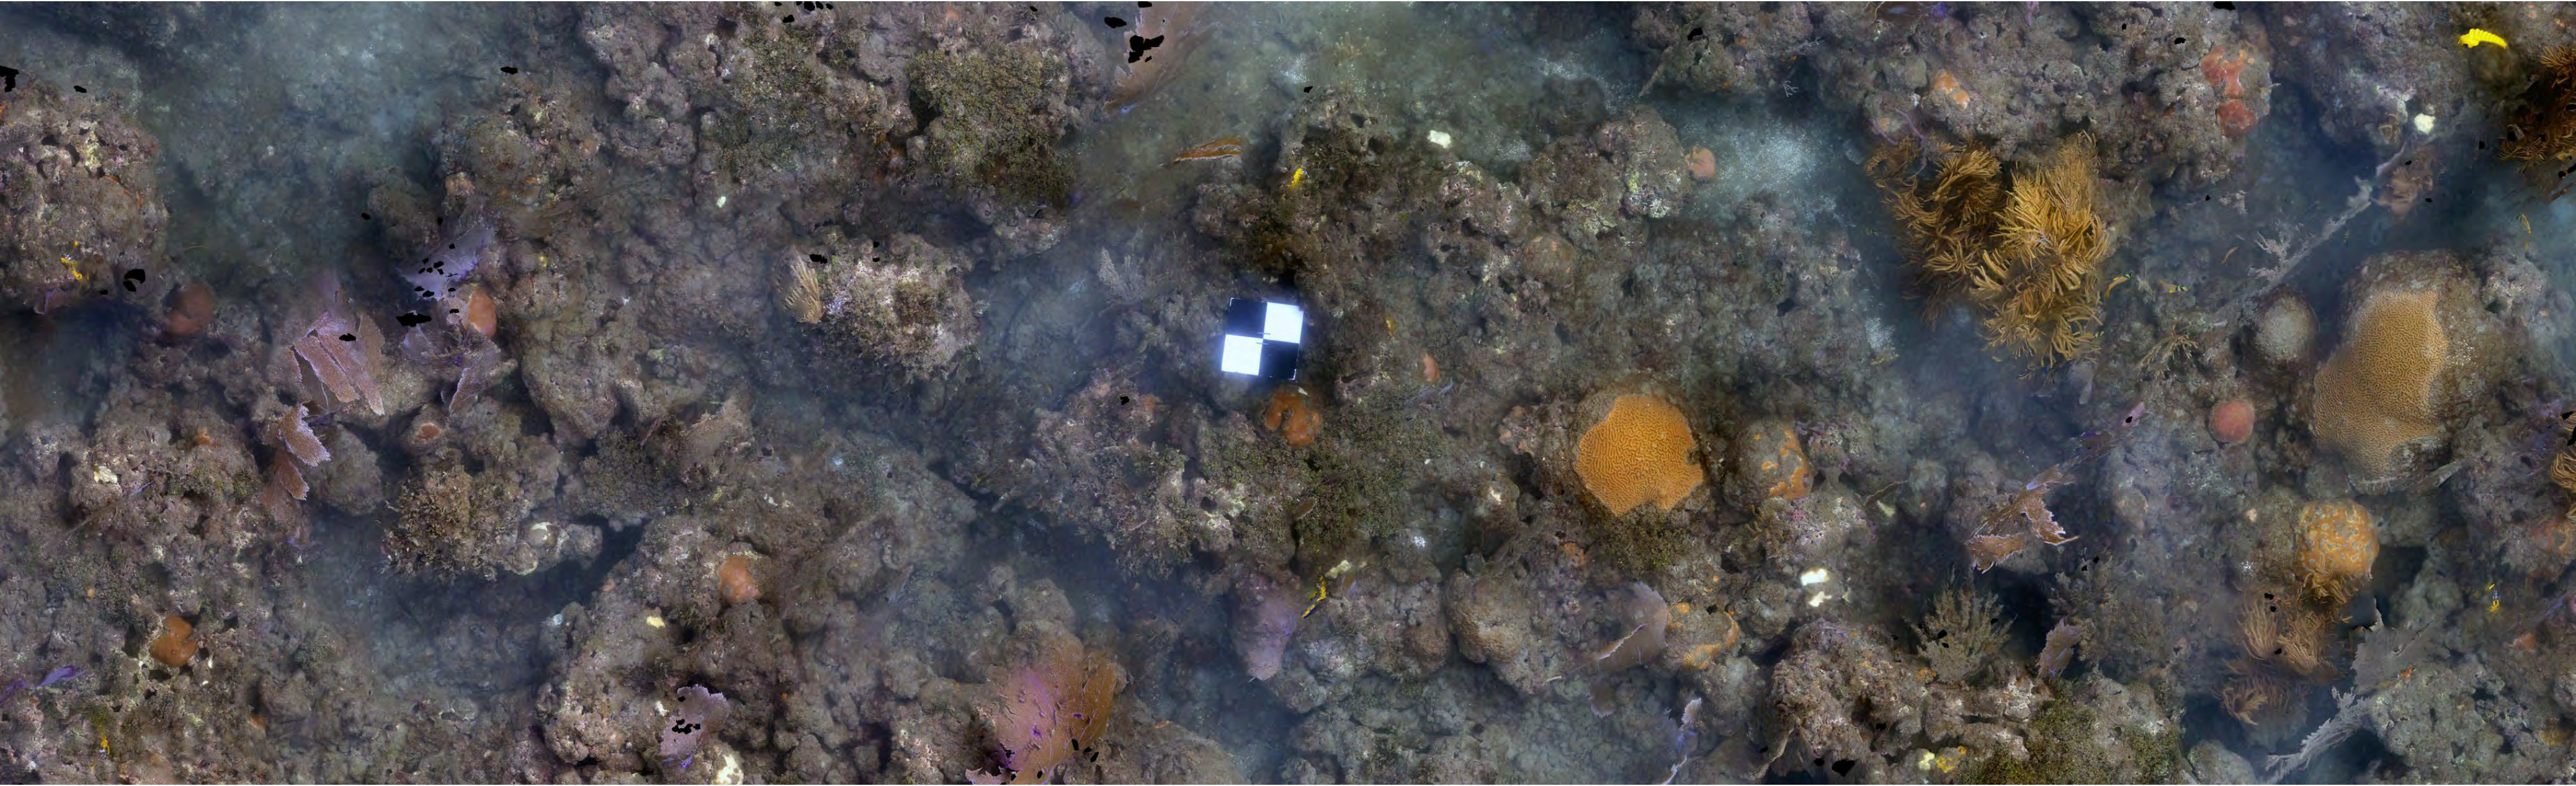
## Orthomosaic of a permanent transect at the Intake station

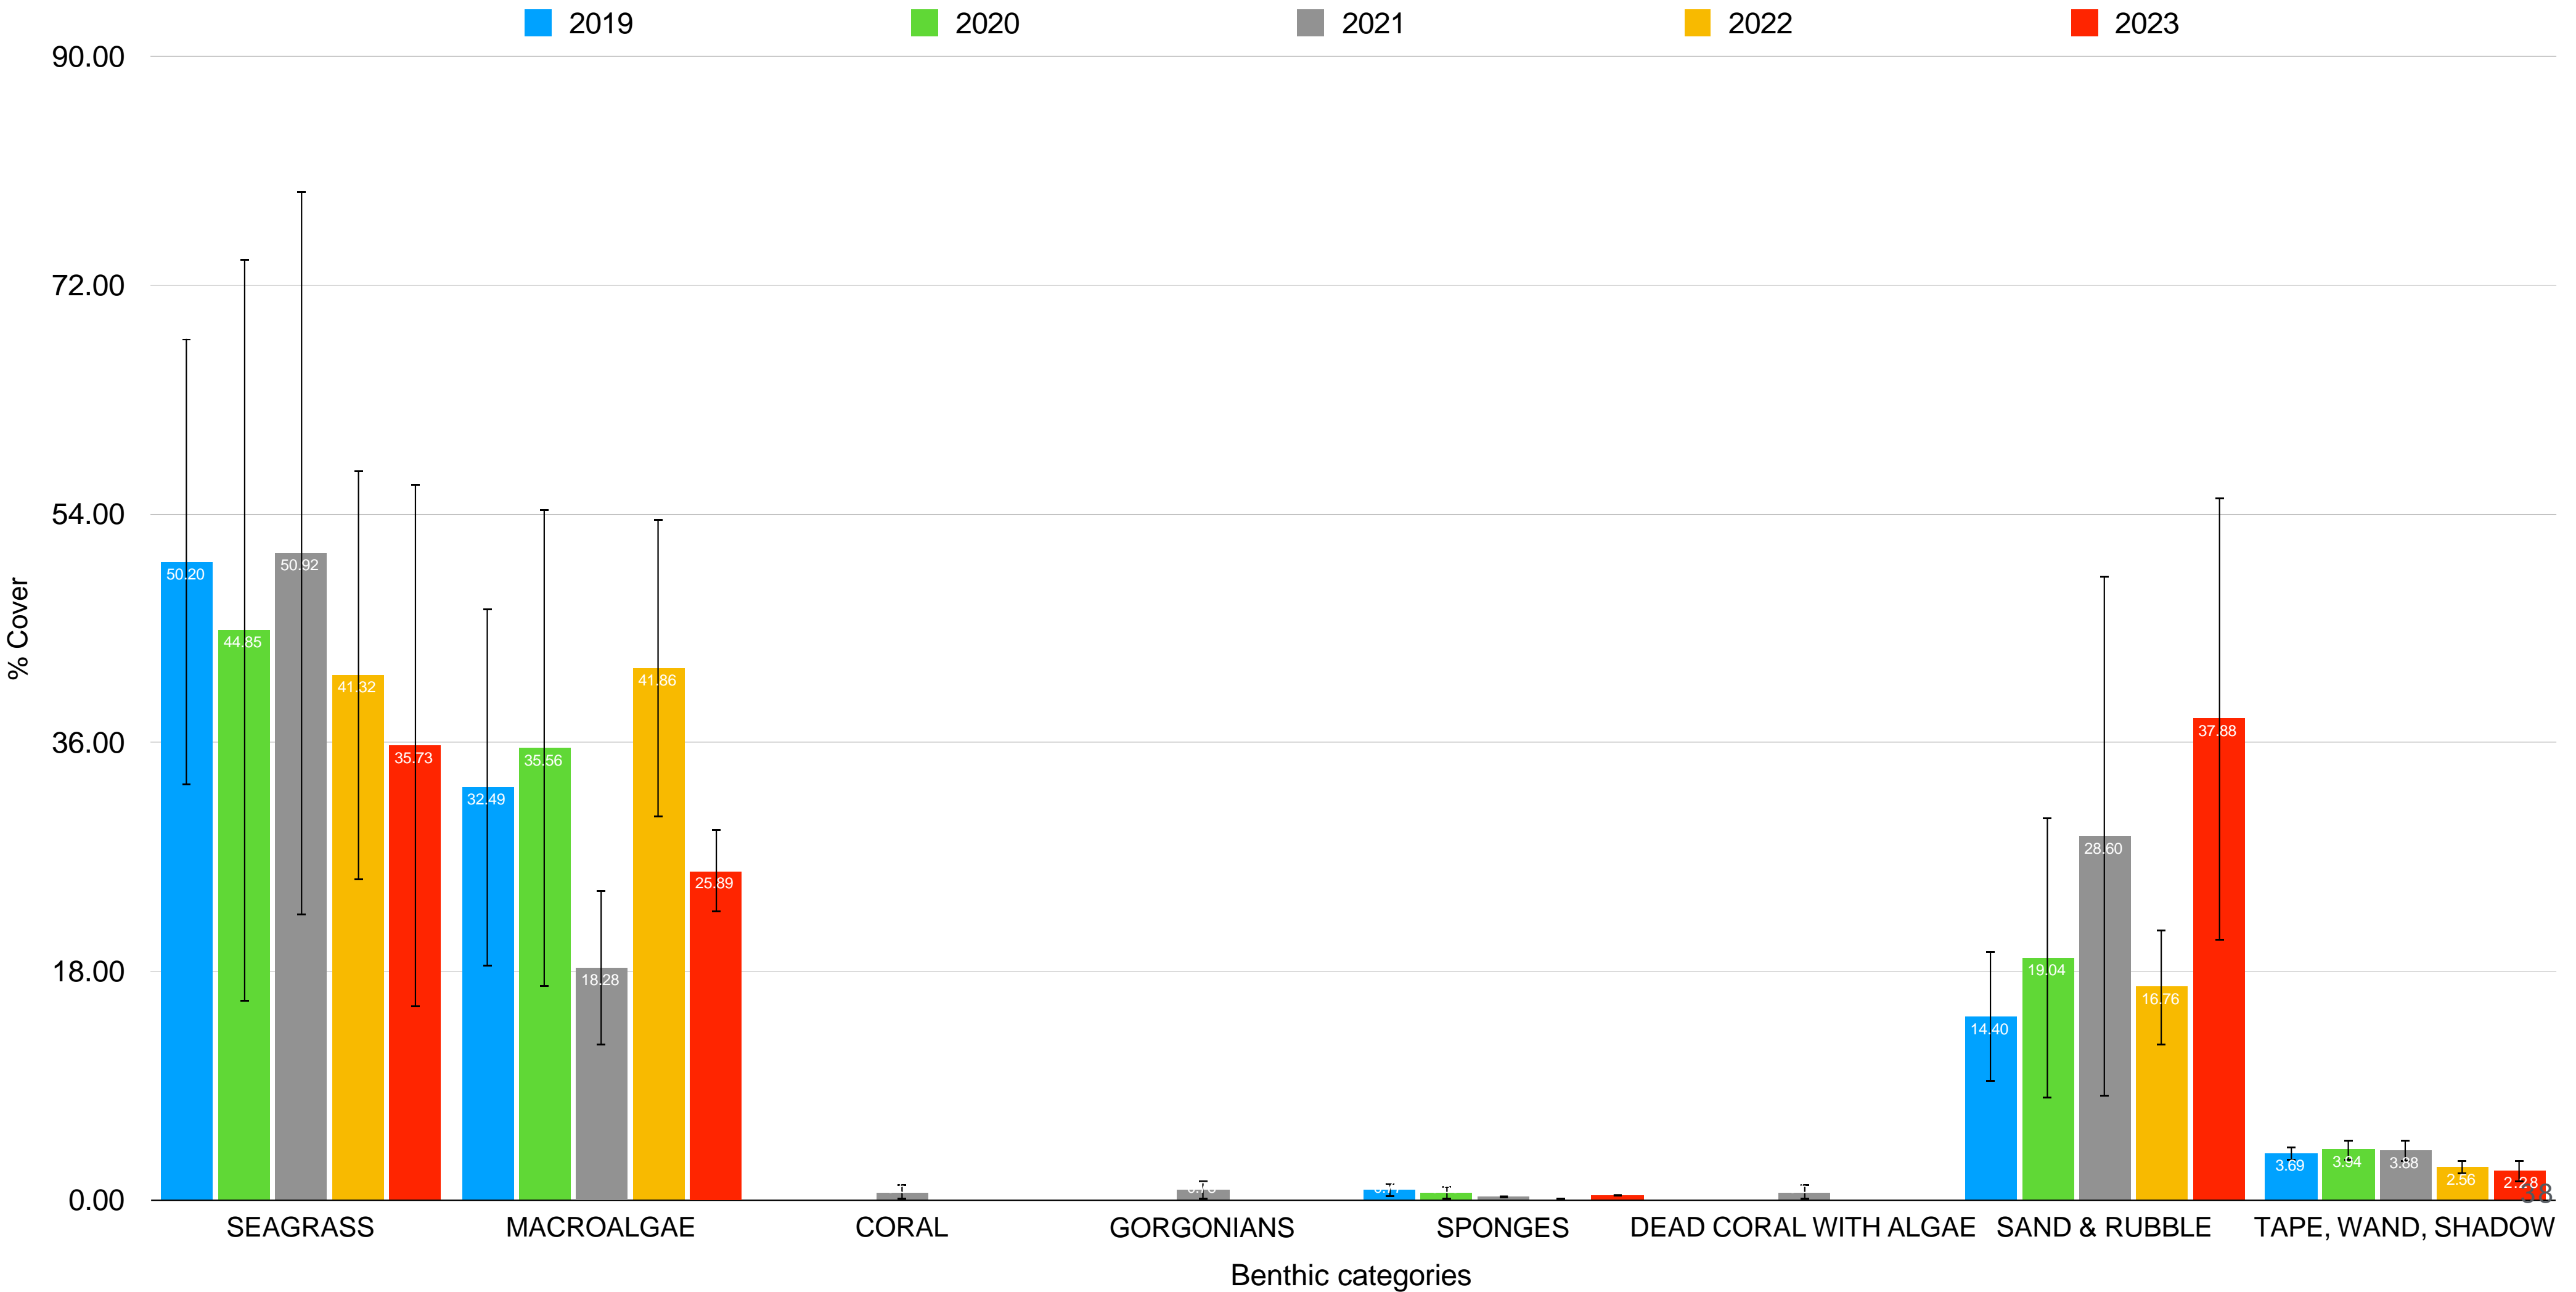
# Soft sediment major categories at discharge station

- *Thalassia testudinum* is the dominant seagrass specie at all stations
- Seagrass cover is **35.73%** at the Discharge
- Seagrass cover is **51.02%** at the Intake
- Seagrass cover is **83.30%** at Maria Langa
- Significant difference since 2022, triggered by burial after Hurricane Fiona

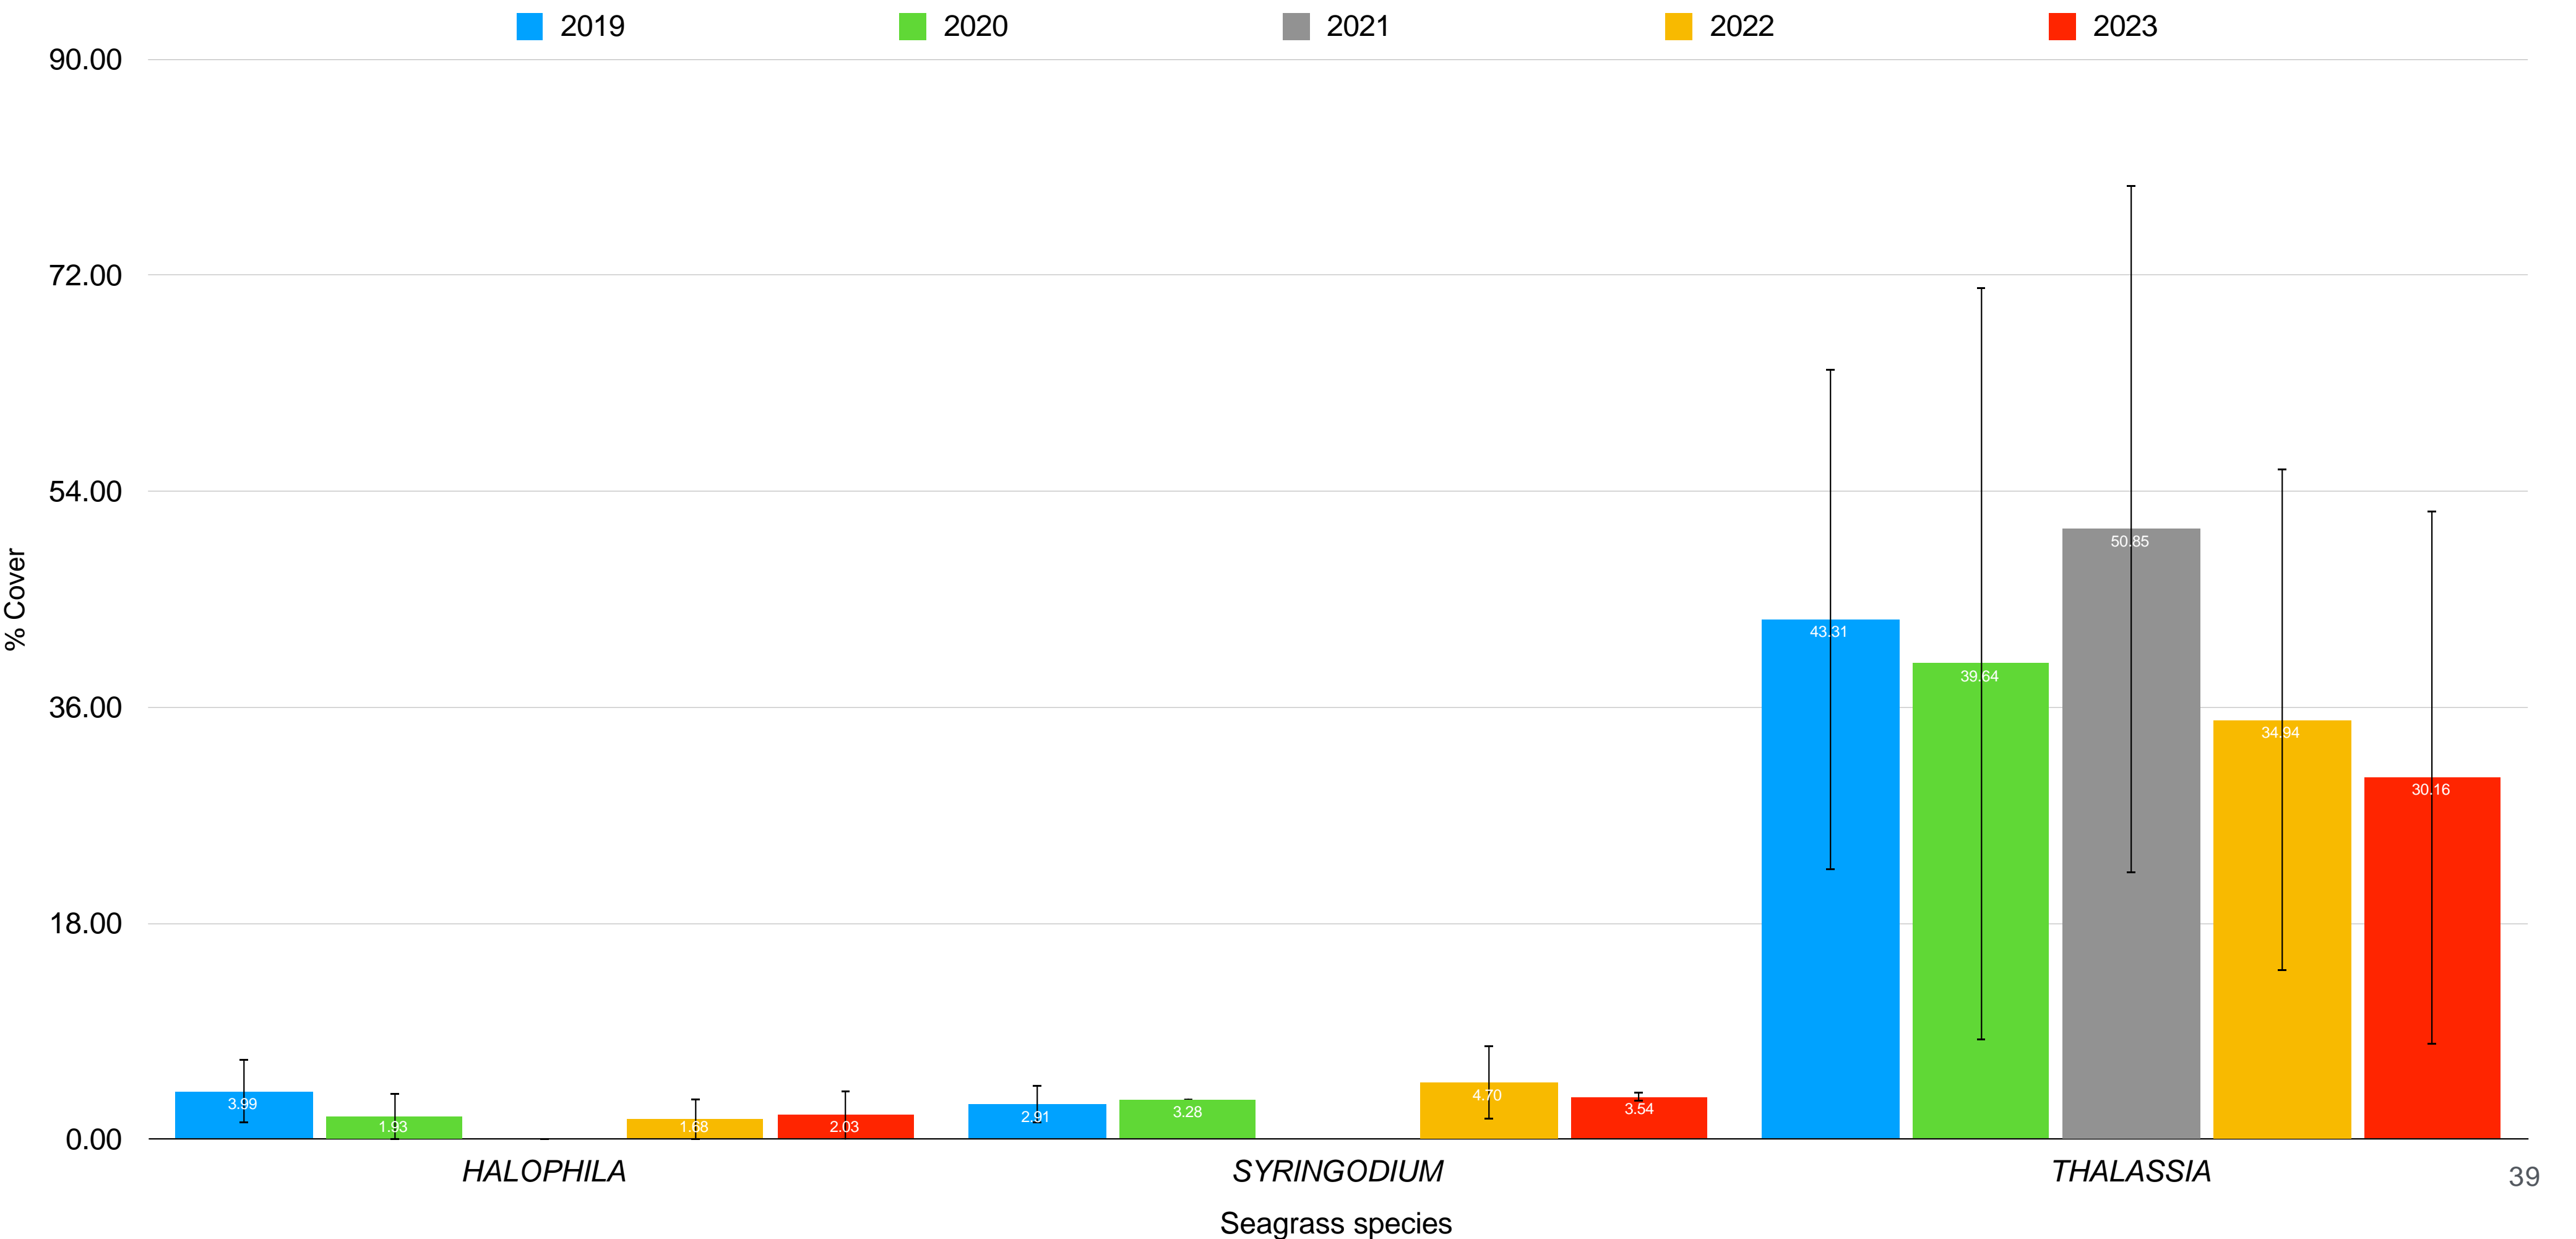
# Discharge station seagrass species cover

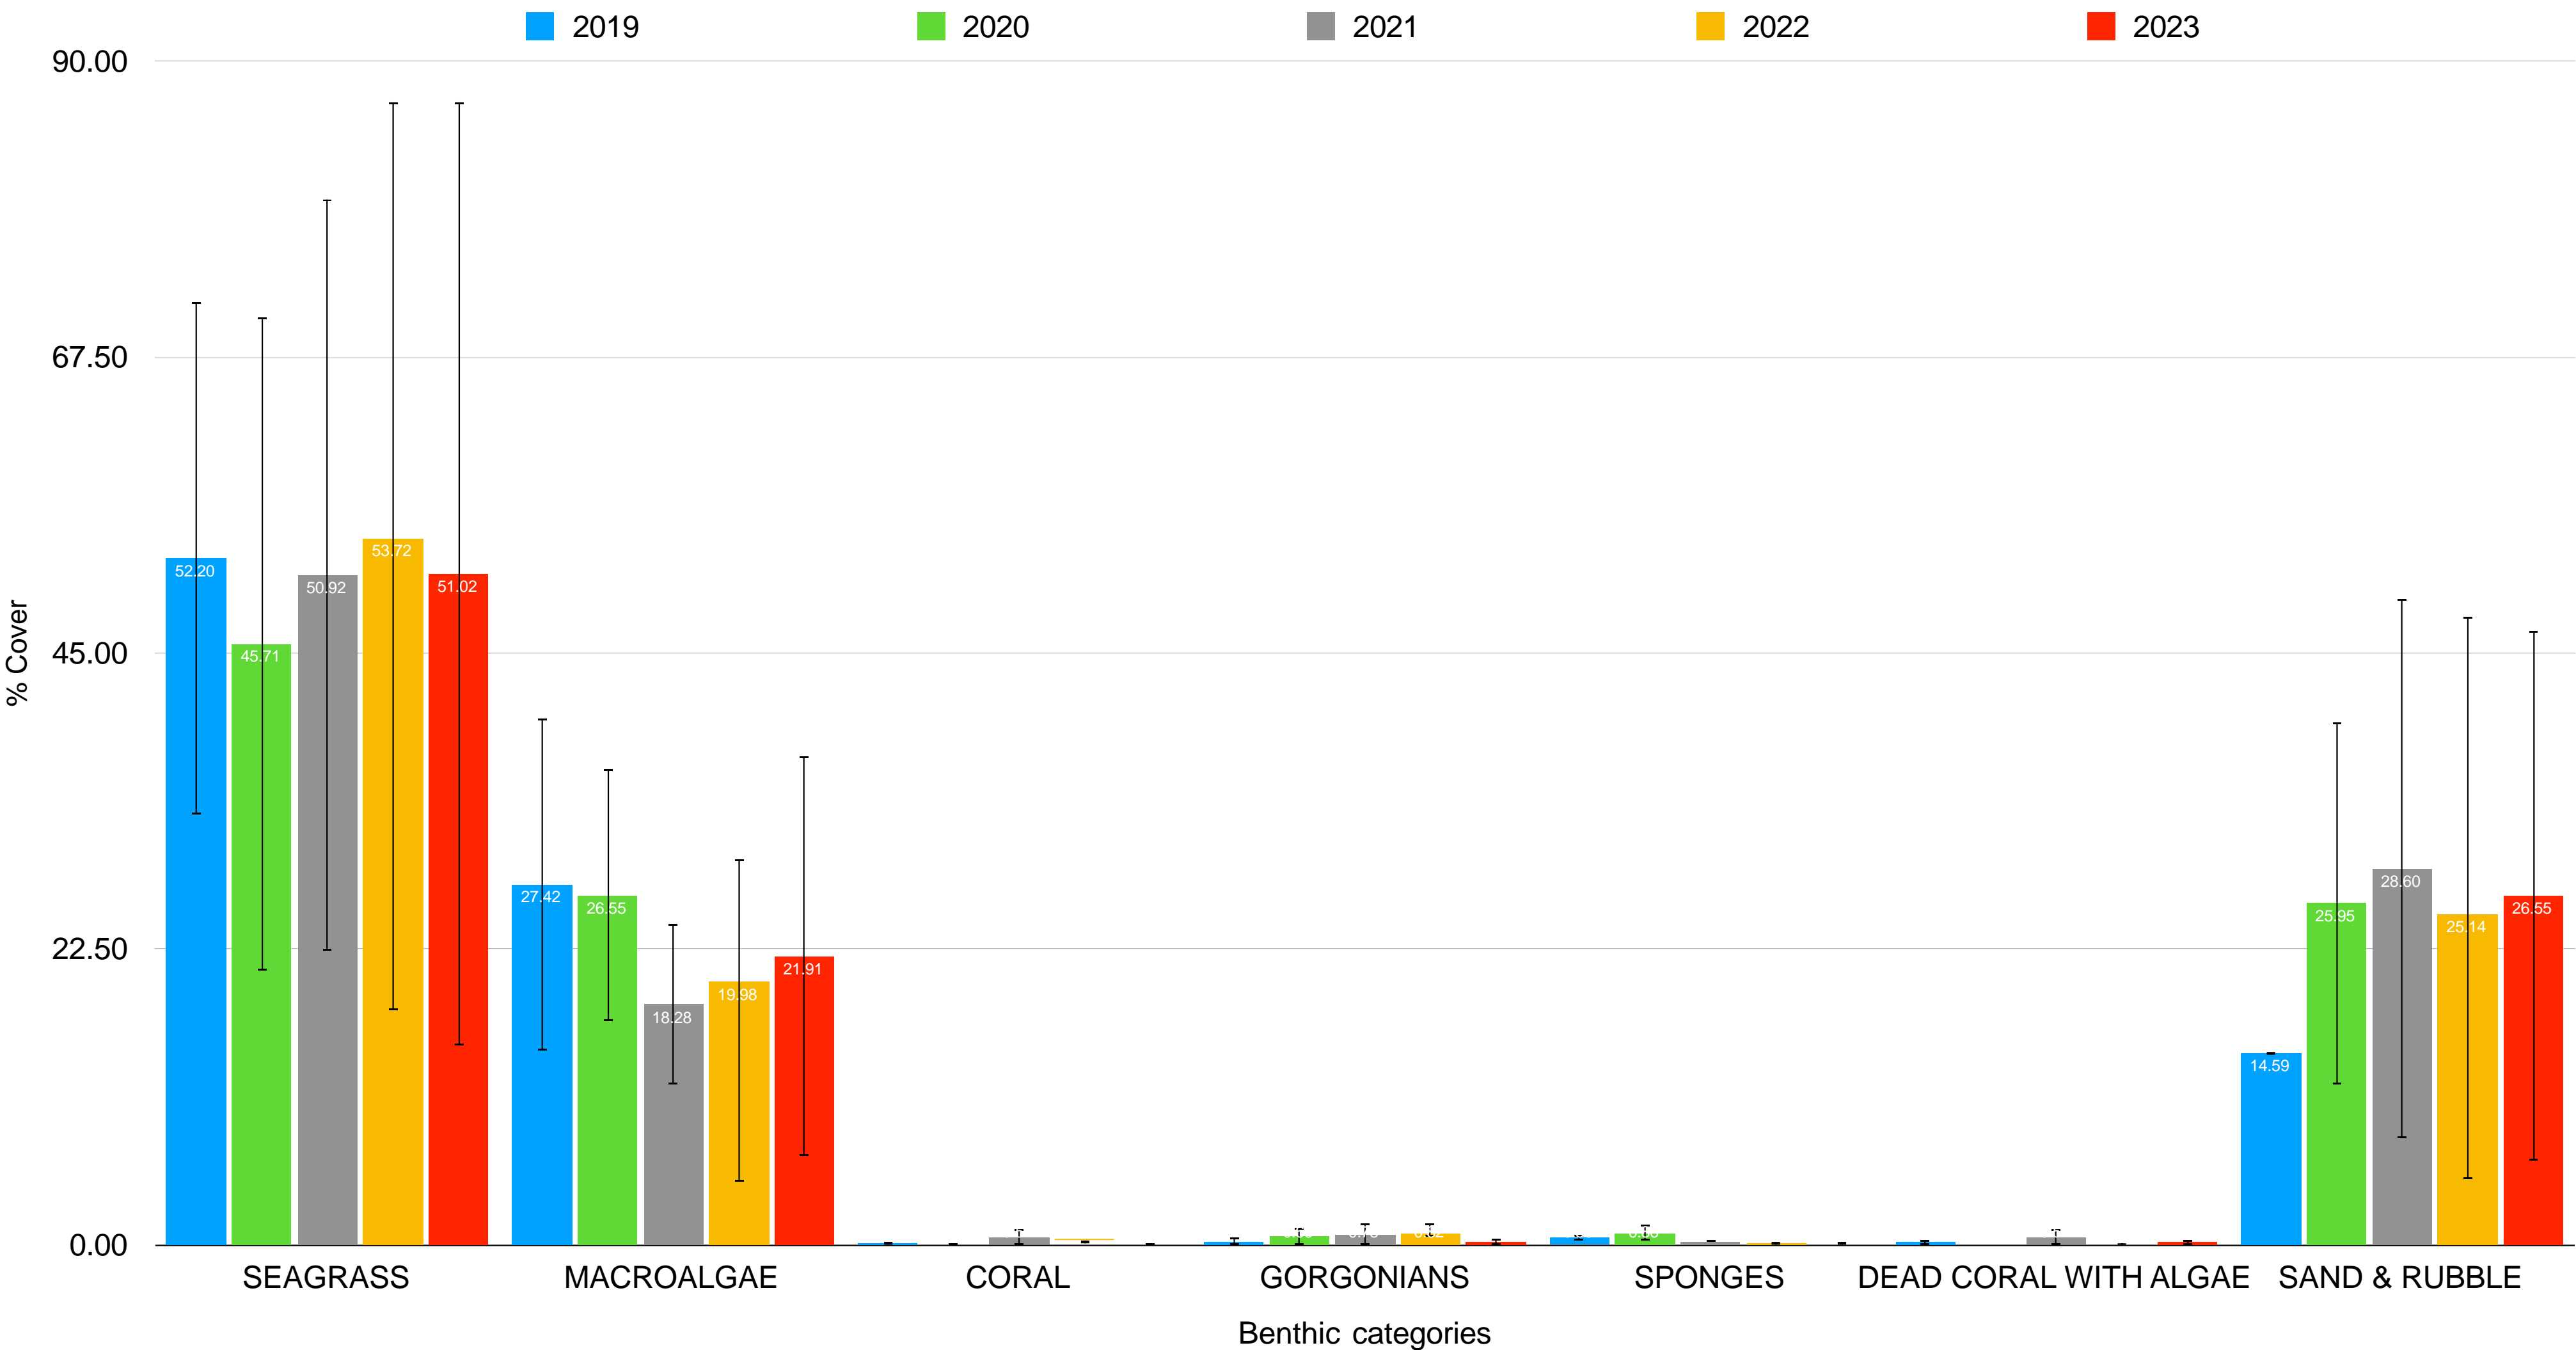
Soft sediment major categories at intake station
