ENVIRONMENTAL PROTECTION AGENCY MEETING  
ECOELÉCTRICA BIOLOGICAL MONITORING PROGRAM  
REGION 2 HEADQUARTERS, NY  
MAY 22, 2024

## EcoEléctrica Biological Monitoring Program Plan (BMPP) 2019-2024 Update

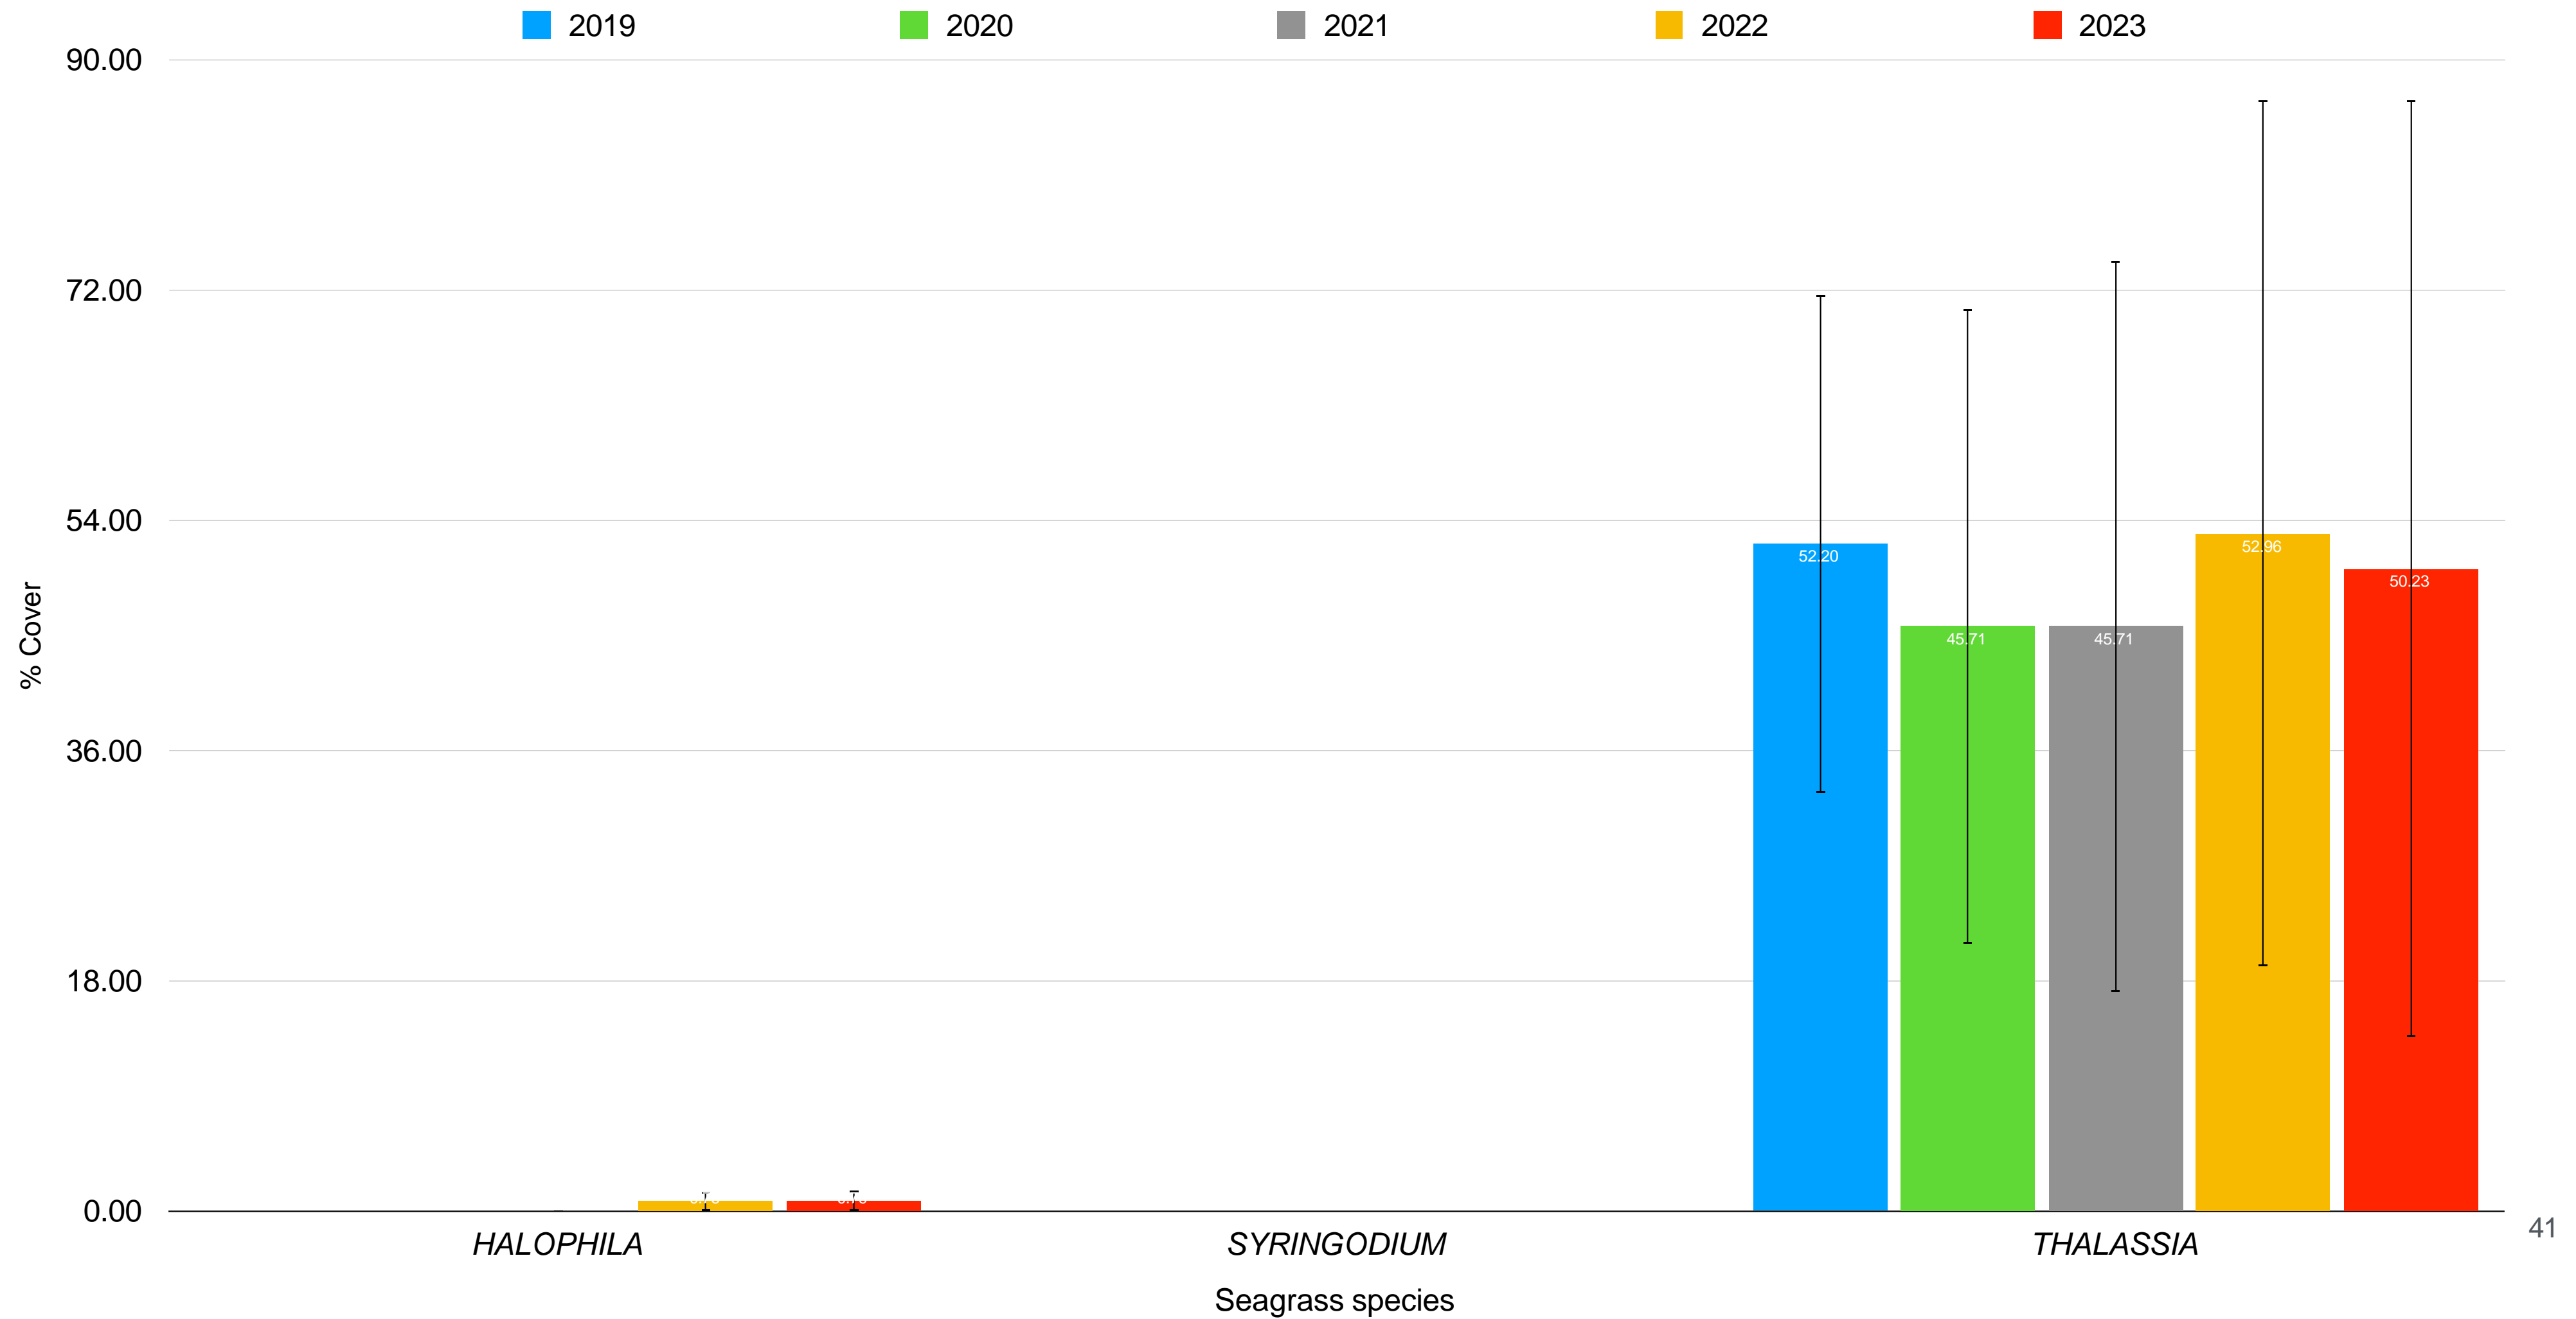
# Intake station seagrass species cover

- *Thalassia testudinum* is the dominant seagrass specie at all stations
- Seagrass cover is **35.73%** at the Discharge
- Seagrass cover is **51.02%** at the Intake
- Seagrass cover is **83.30%** at Maria Langa
- Significant difference since 2022, triggered by burial after Hurricane Fiona

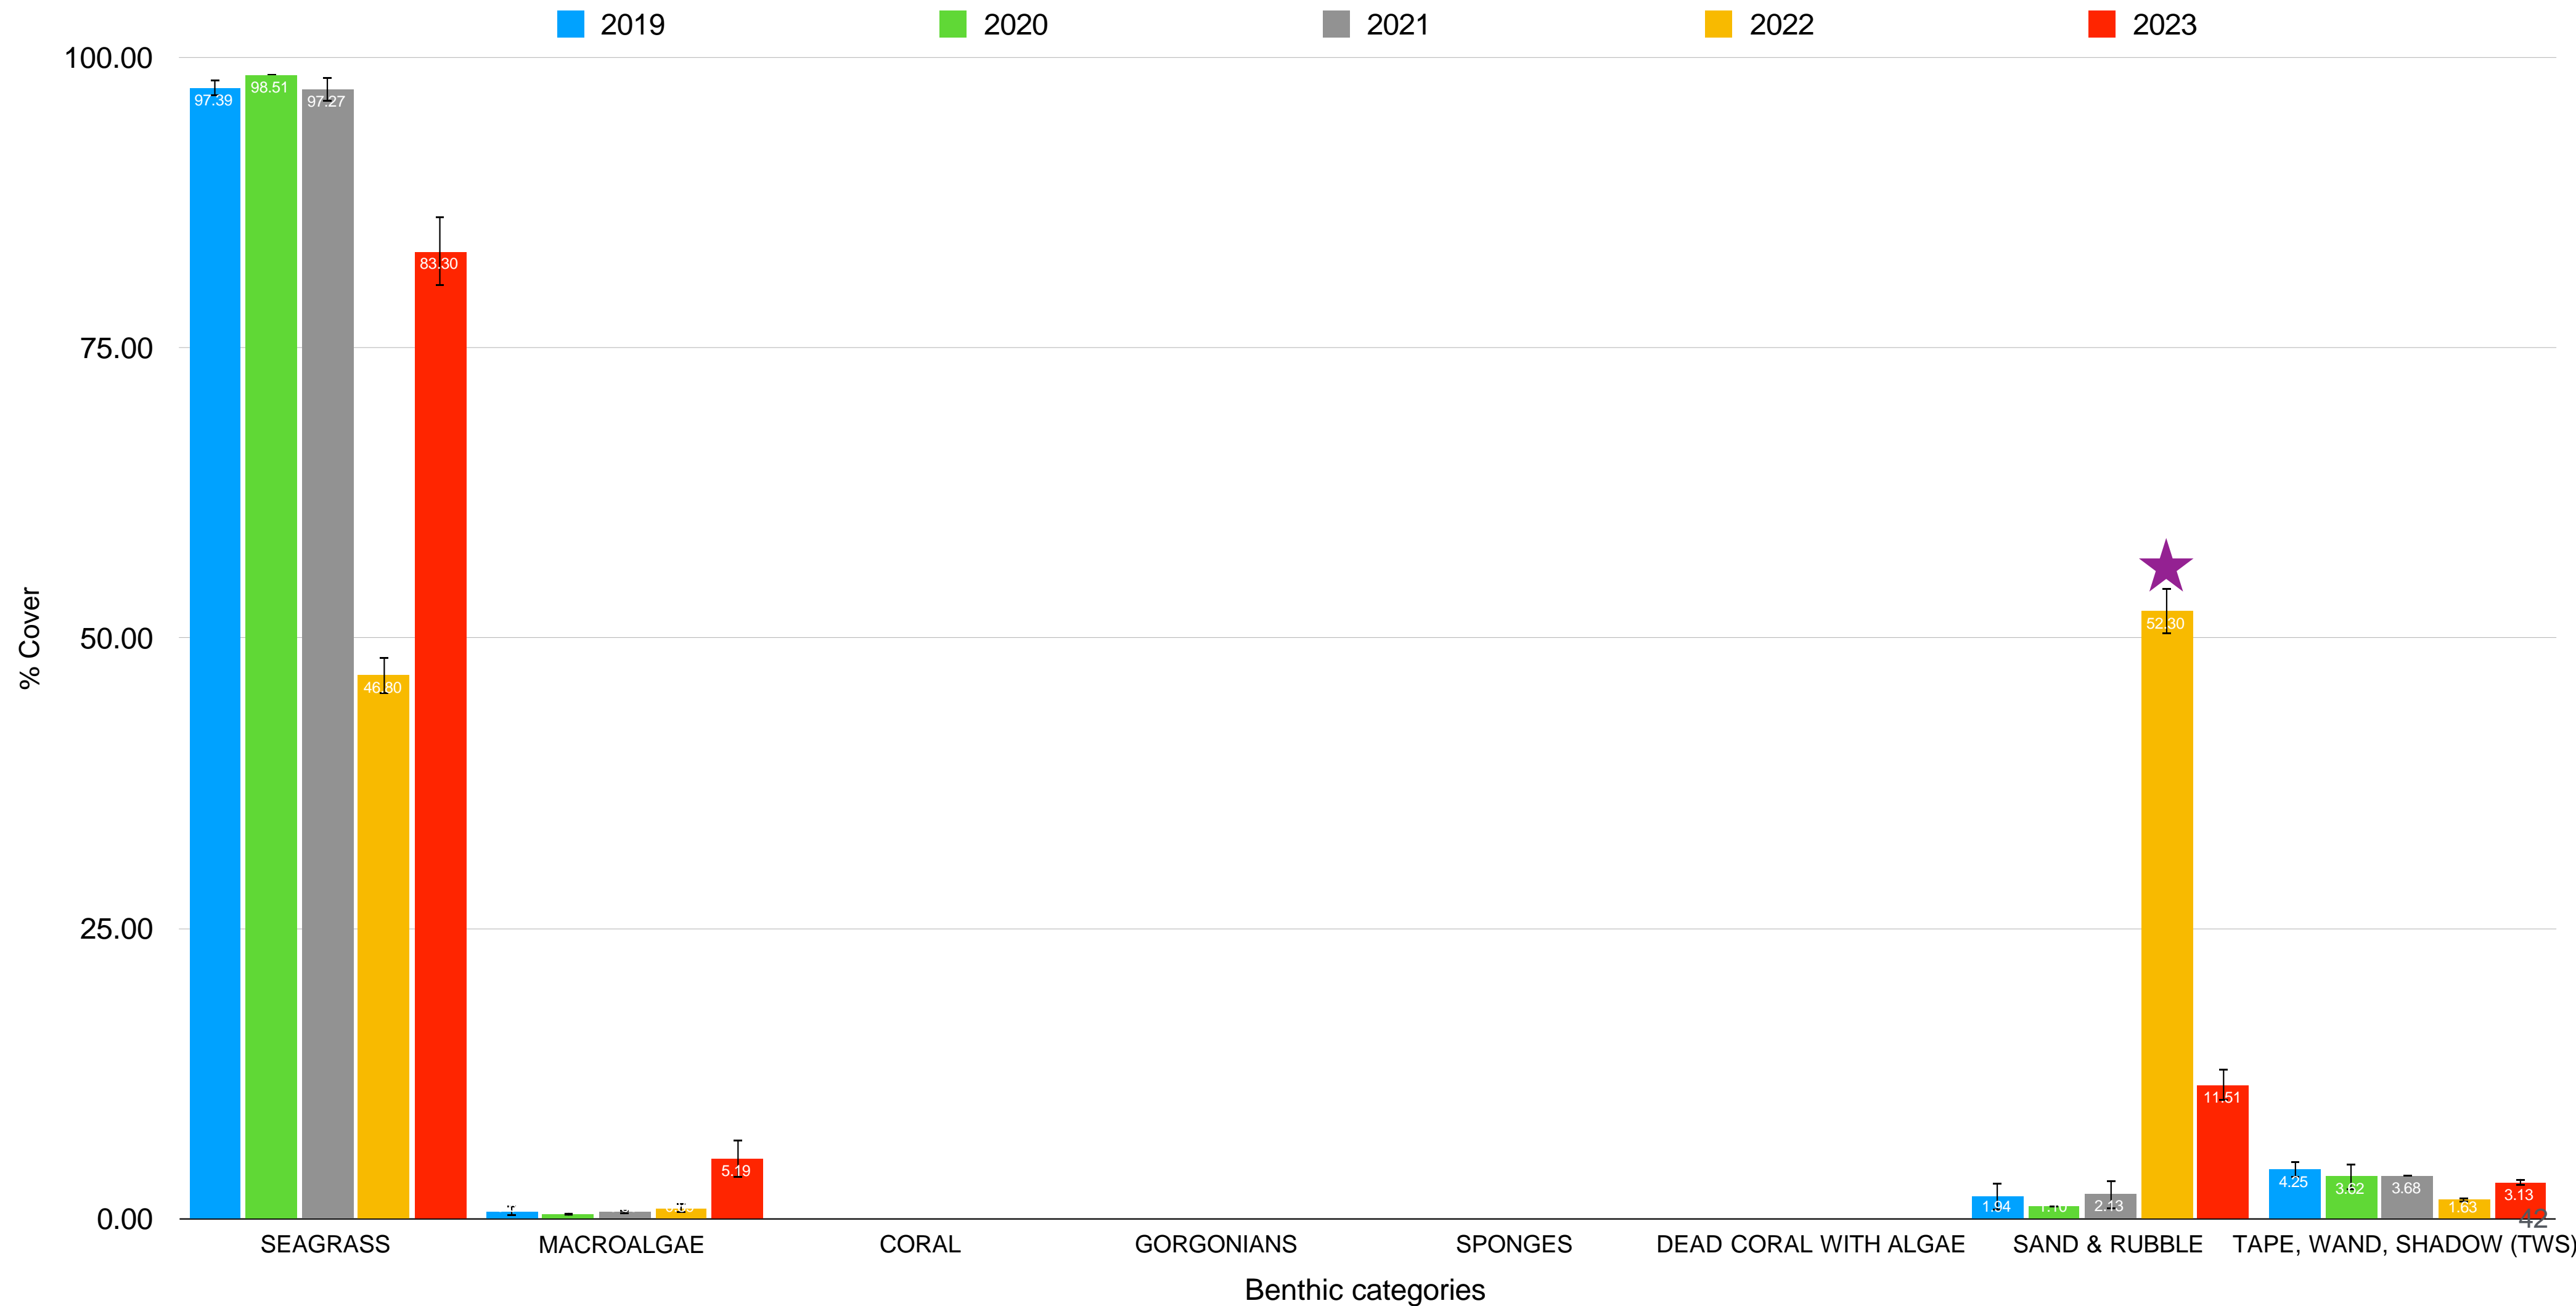
# Soft sediment major categories at Maria Langa station

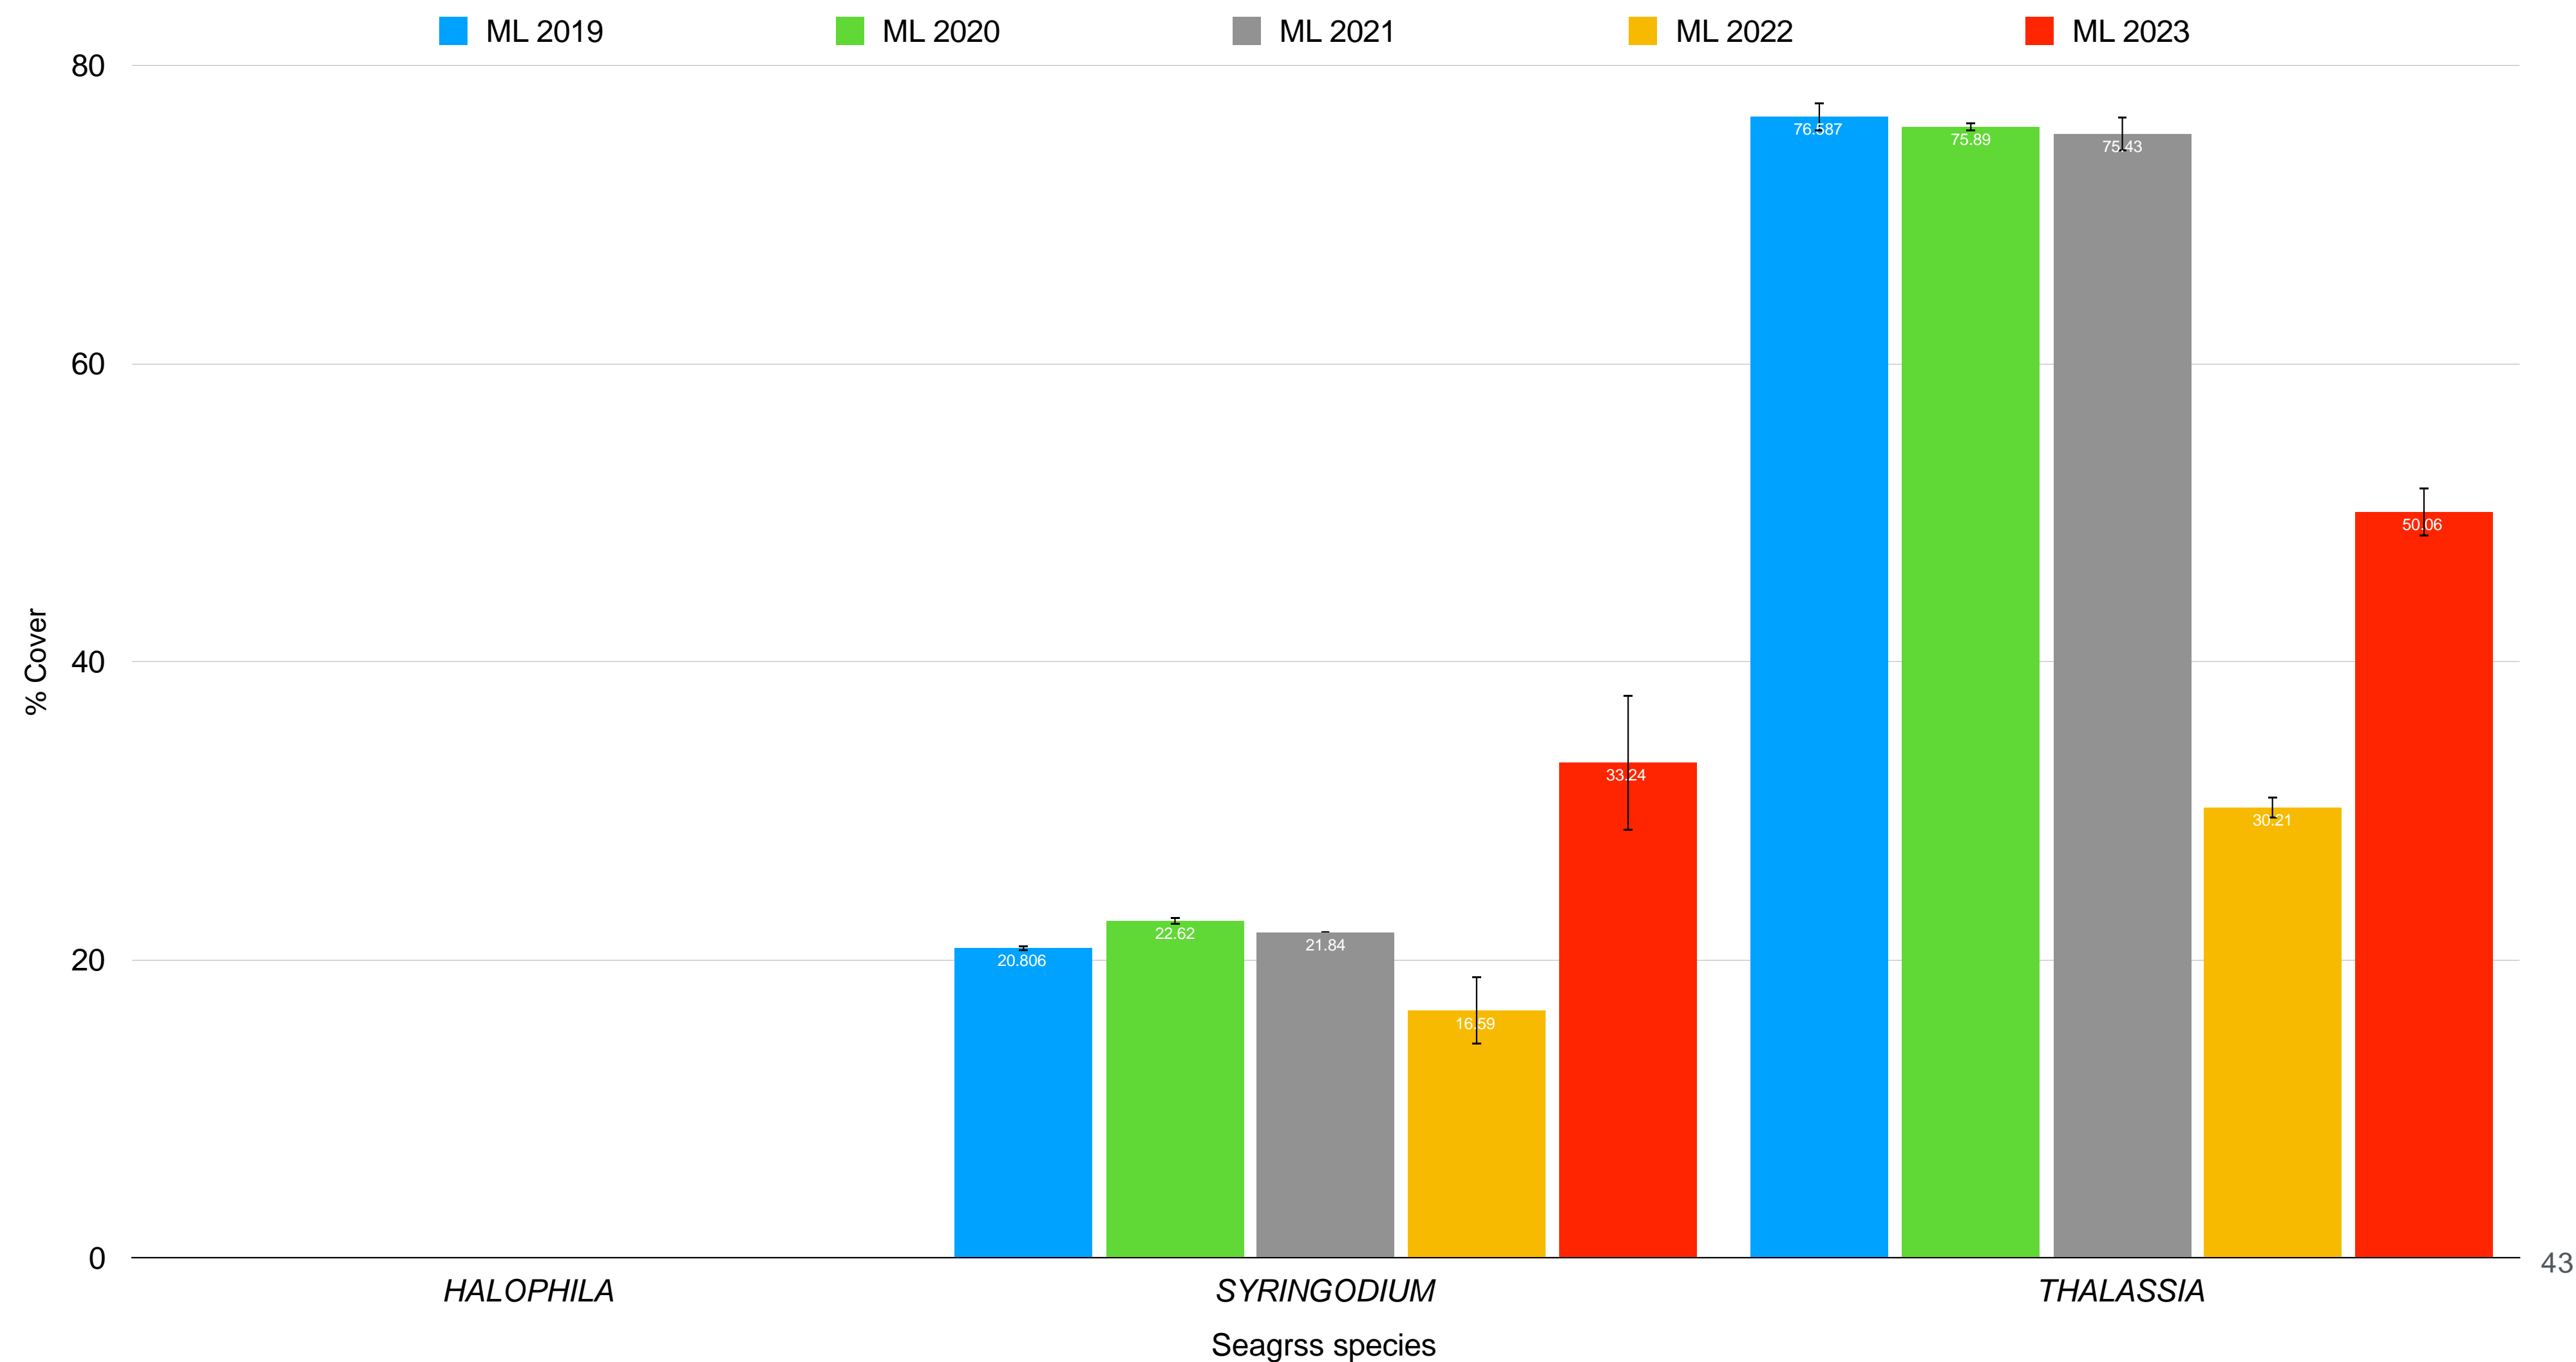
# Maria Langa seagrass species cover

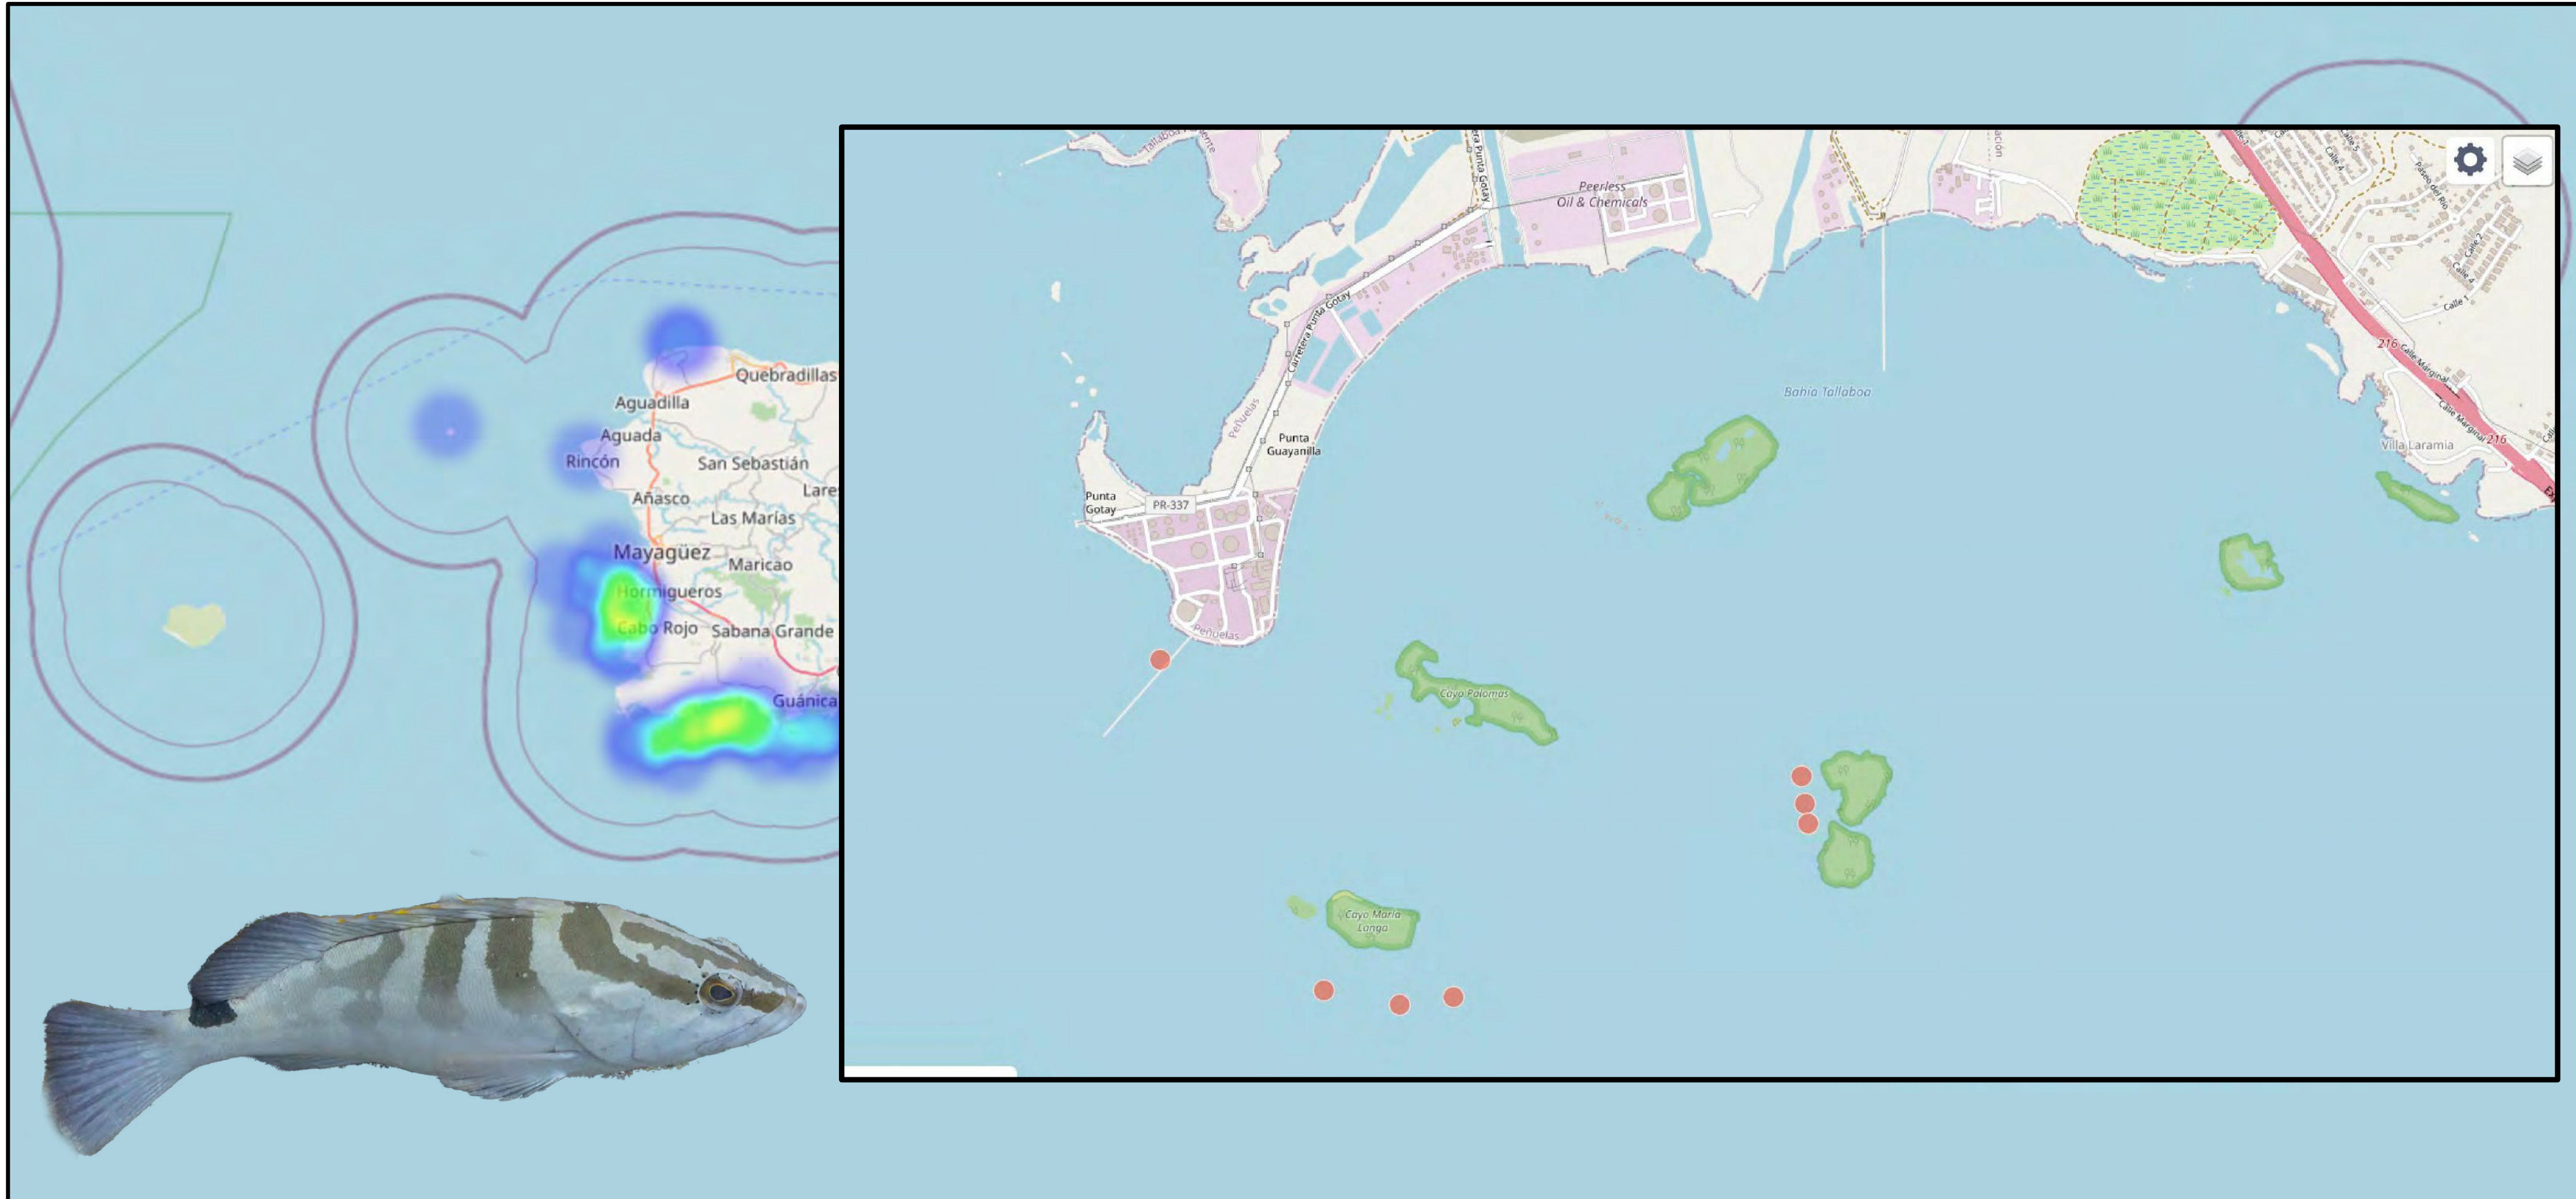
# Heat Map of Nassau Grouper reports

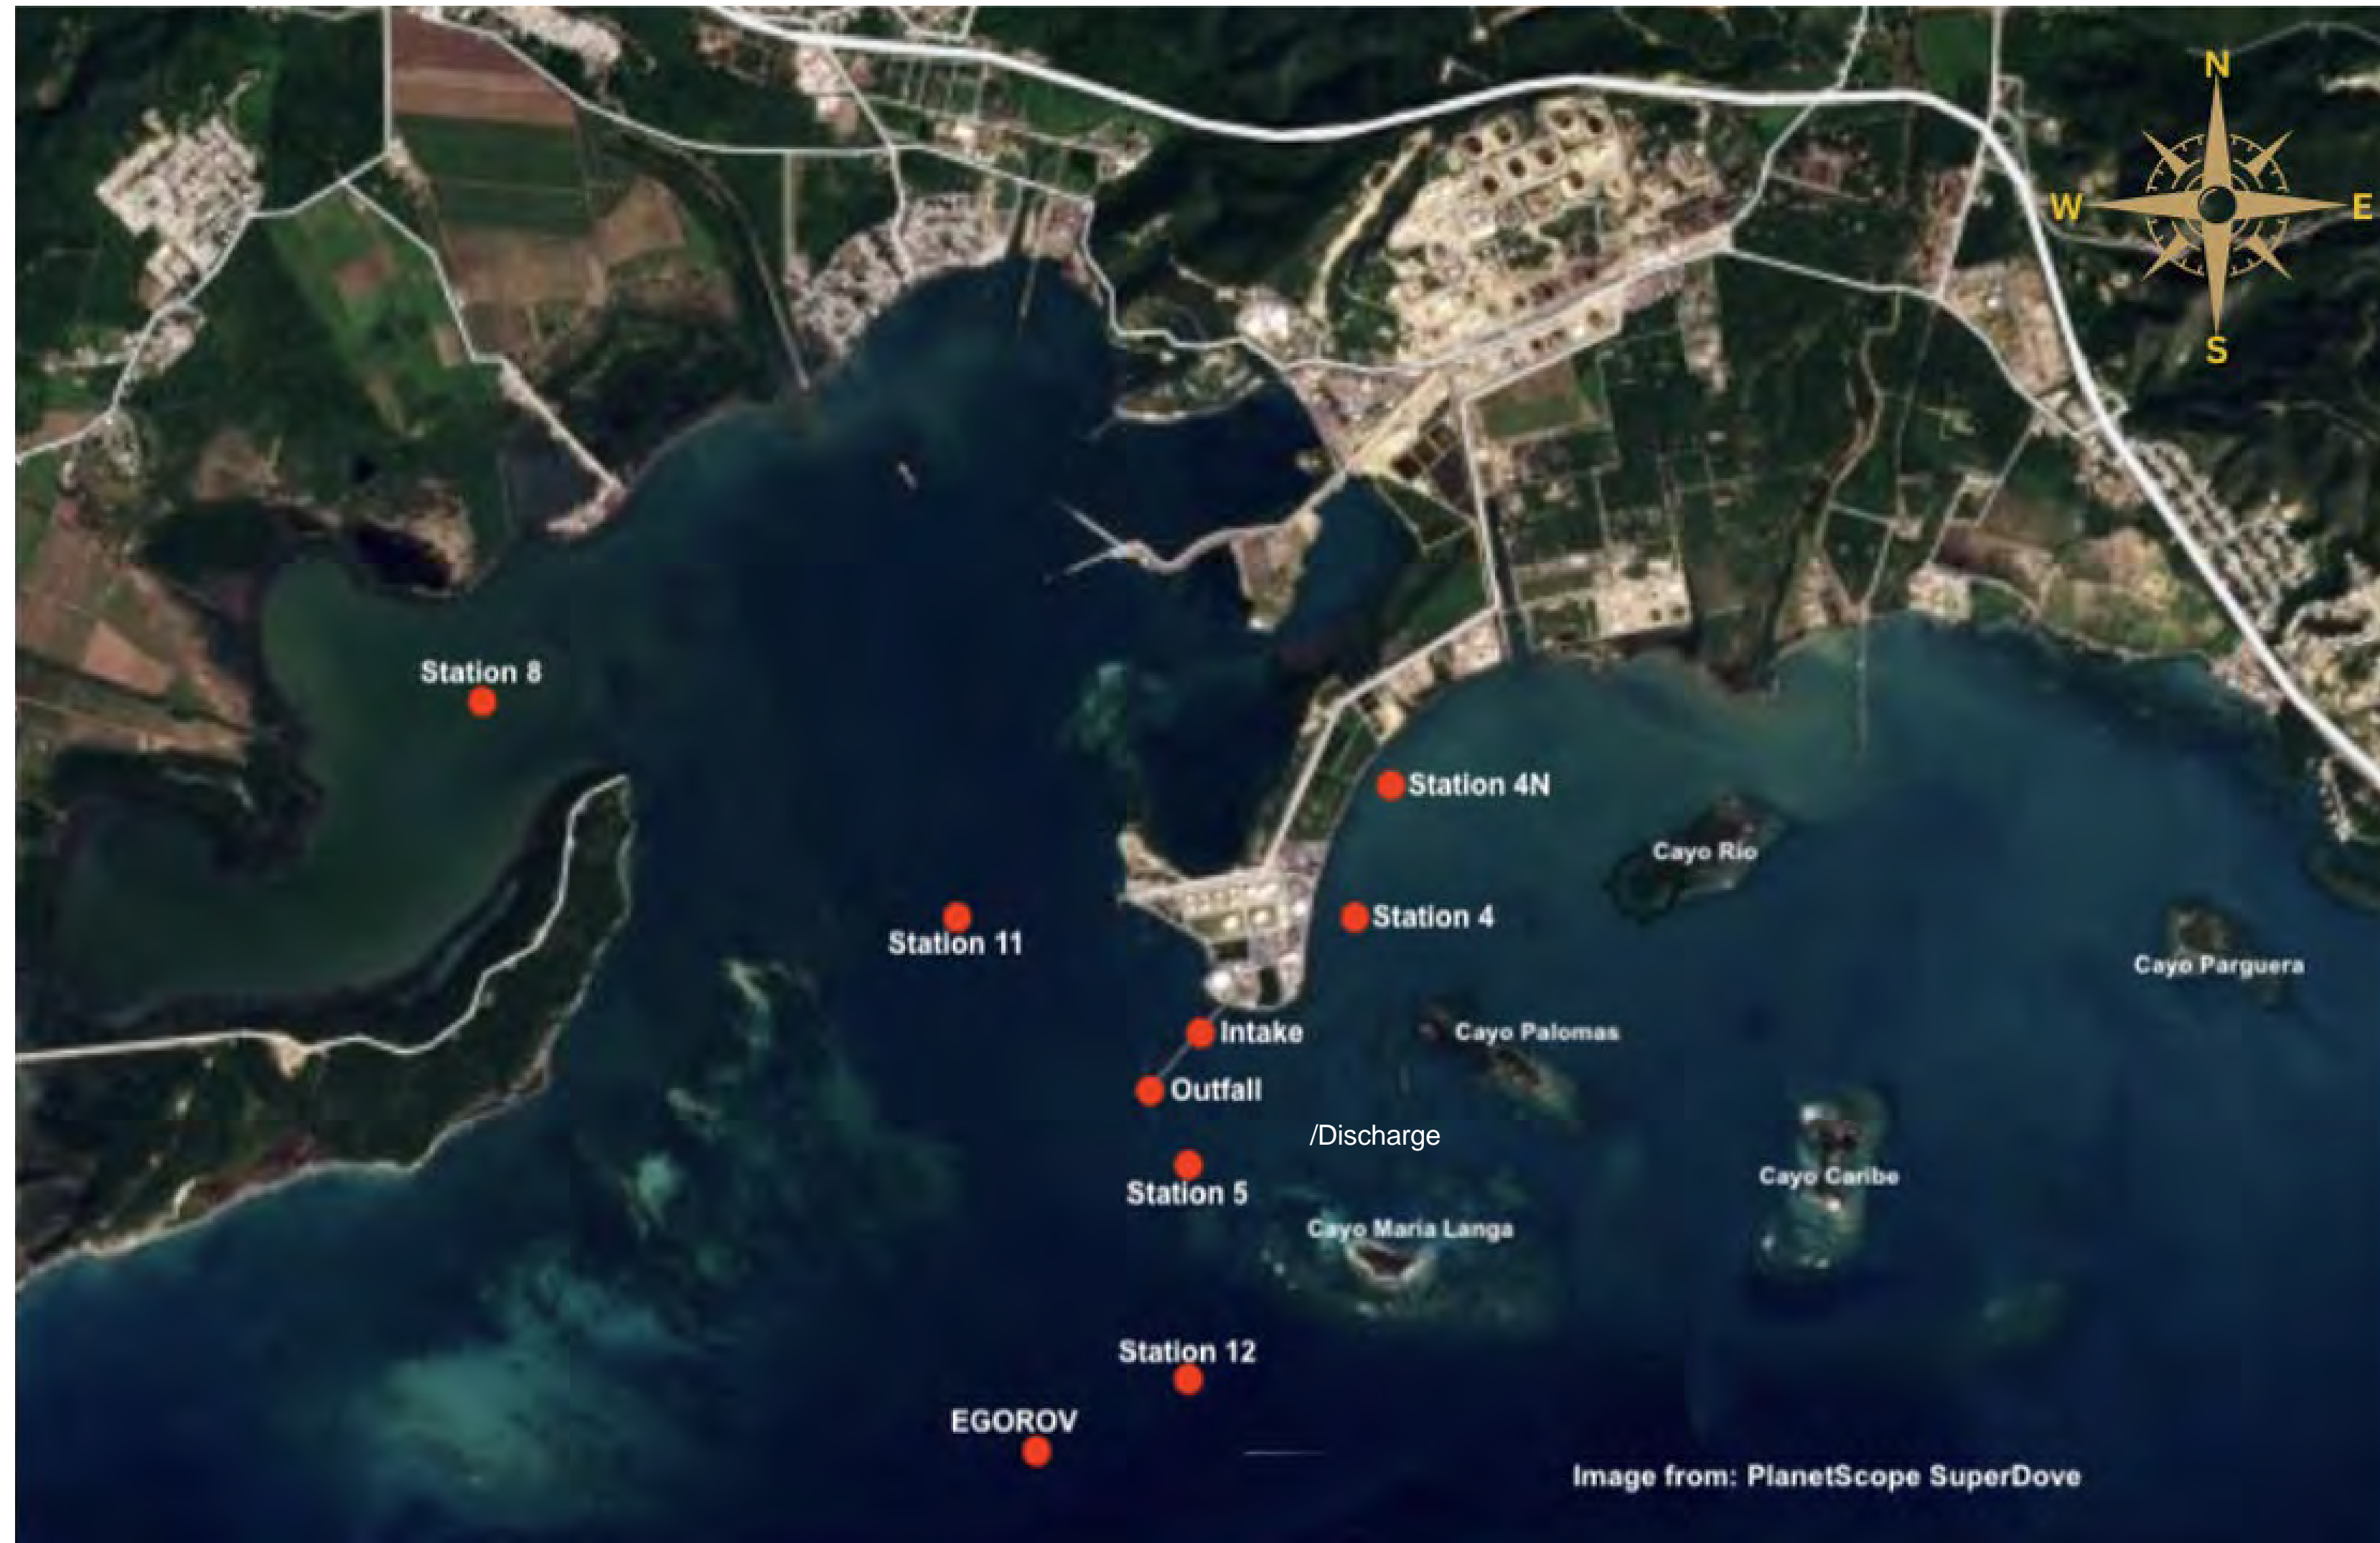
# Sampling Stations

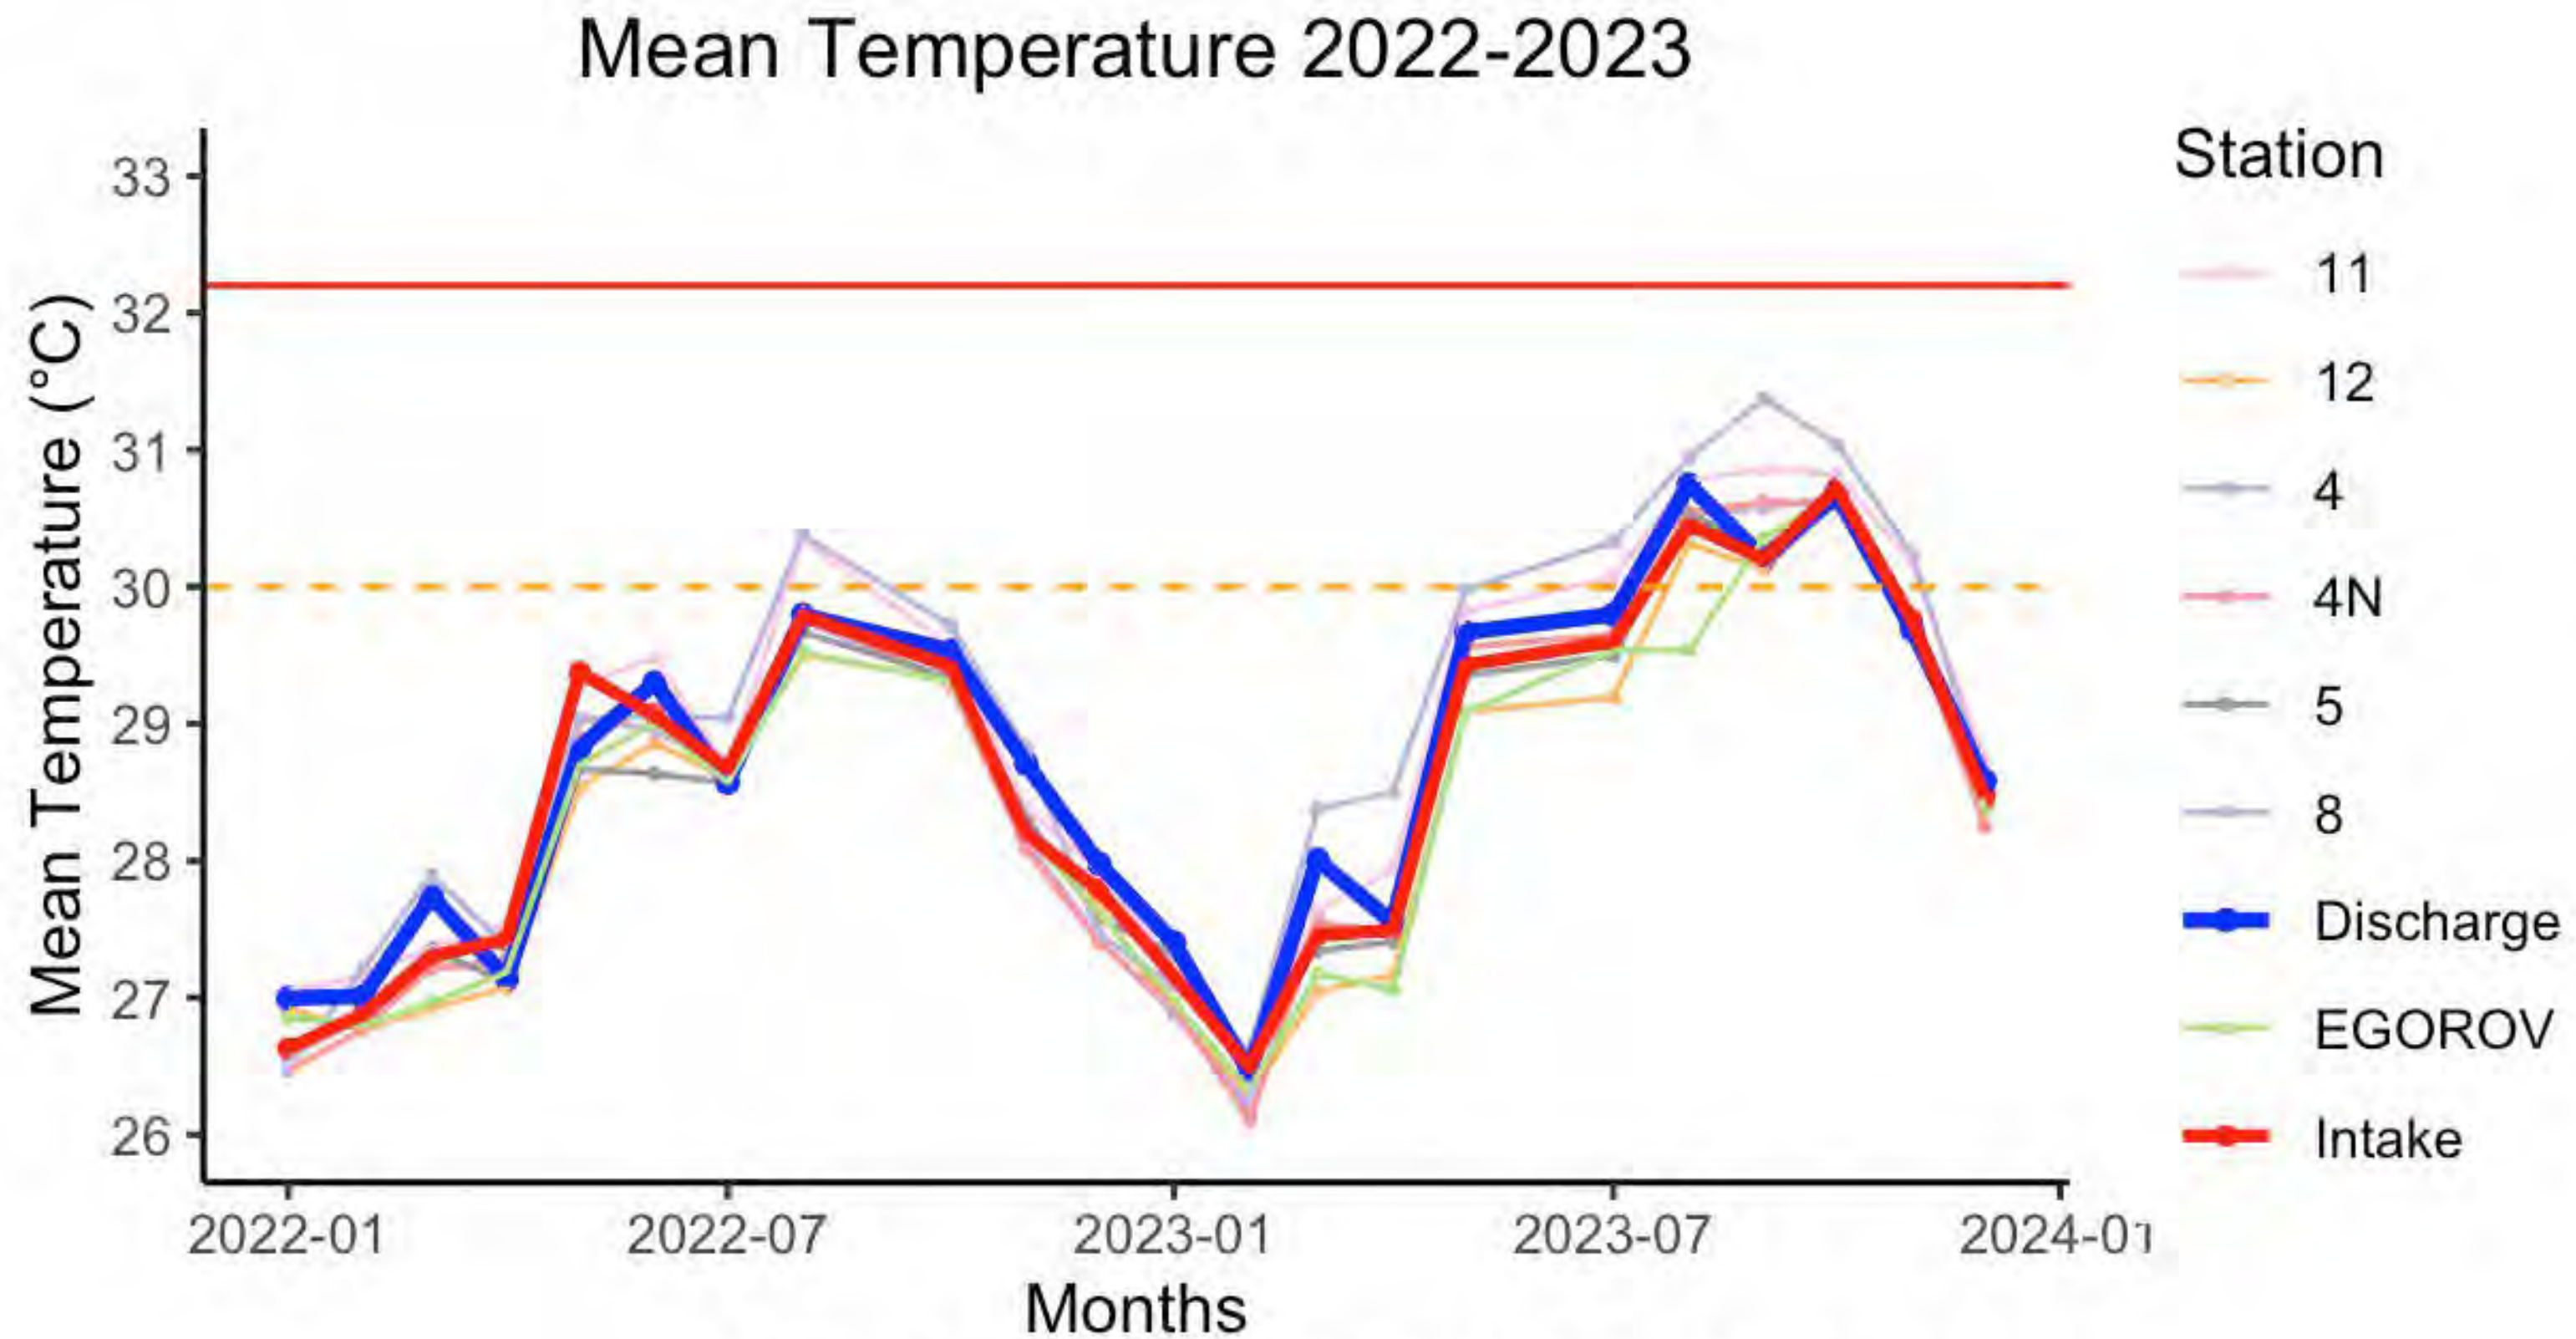
# Monthly Monitoring- Temperature

Data collected from monthly CTD (CastAway) sampling

- An overall well mixed vertical distribution was observed.
- 0.9°C higher 2023 vs. 2022 (0.6°C higher in 2020!)
- No statistical difference found within stations during monthly monitoring.
