ENVIRONMENTAL PROTECTION AGENCY MEETING  
ECOELÉCTRICA BIOLOGICAL MONITORING PROGRAM  
REGION 2 HEADQUARTERS, NY  
MAY 22, 2024

## EcoEléctrica Biological Monitoring Program Plan (BMPP) 2019-2024 Update

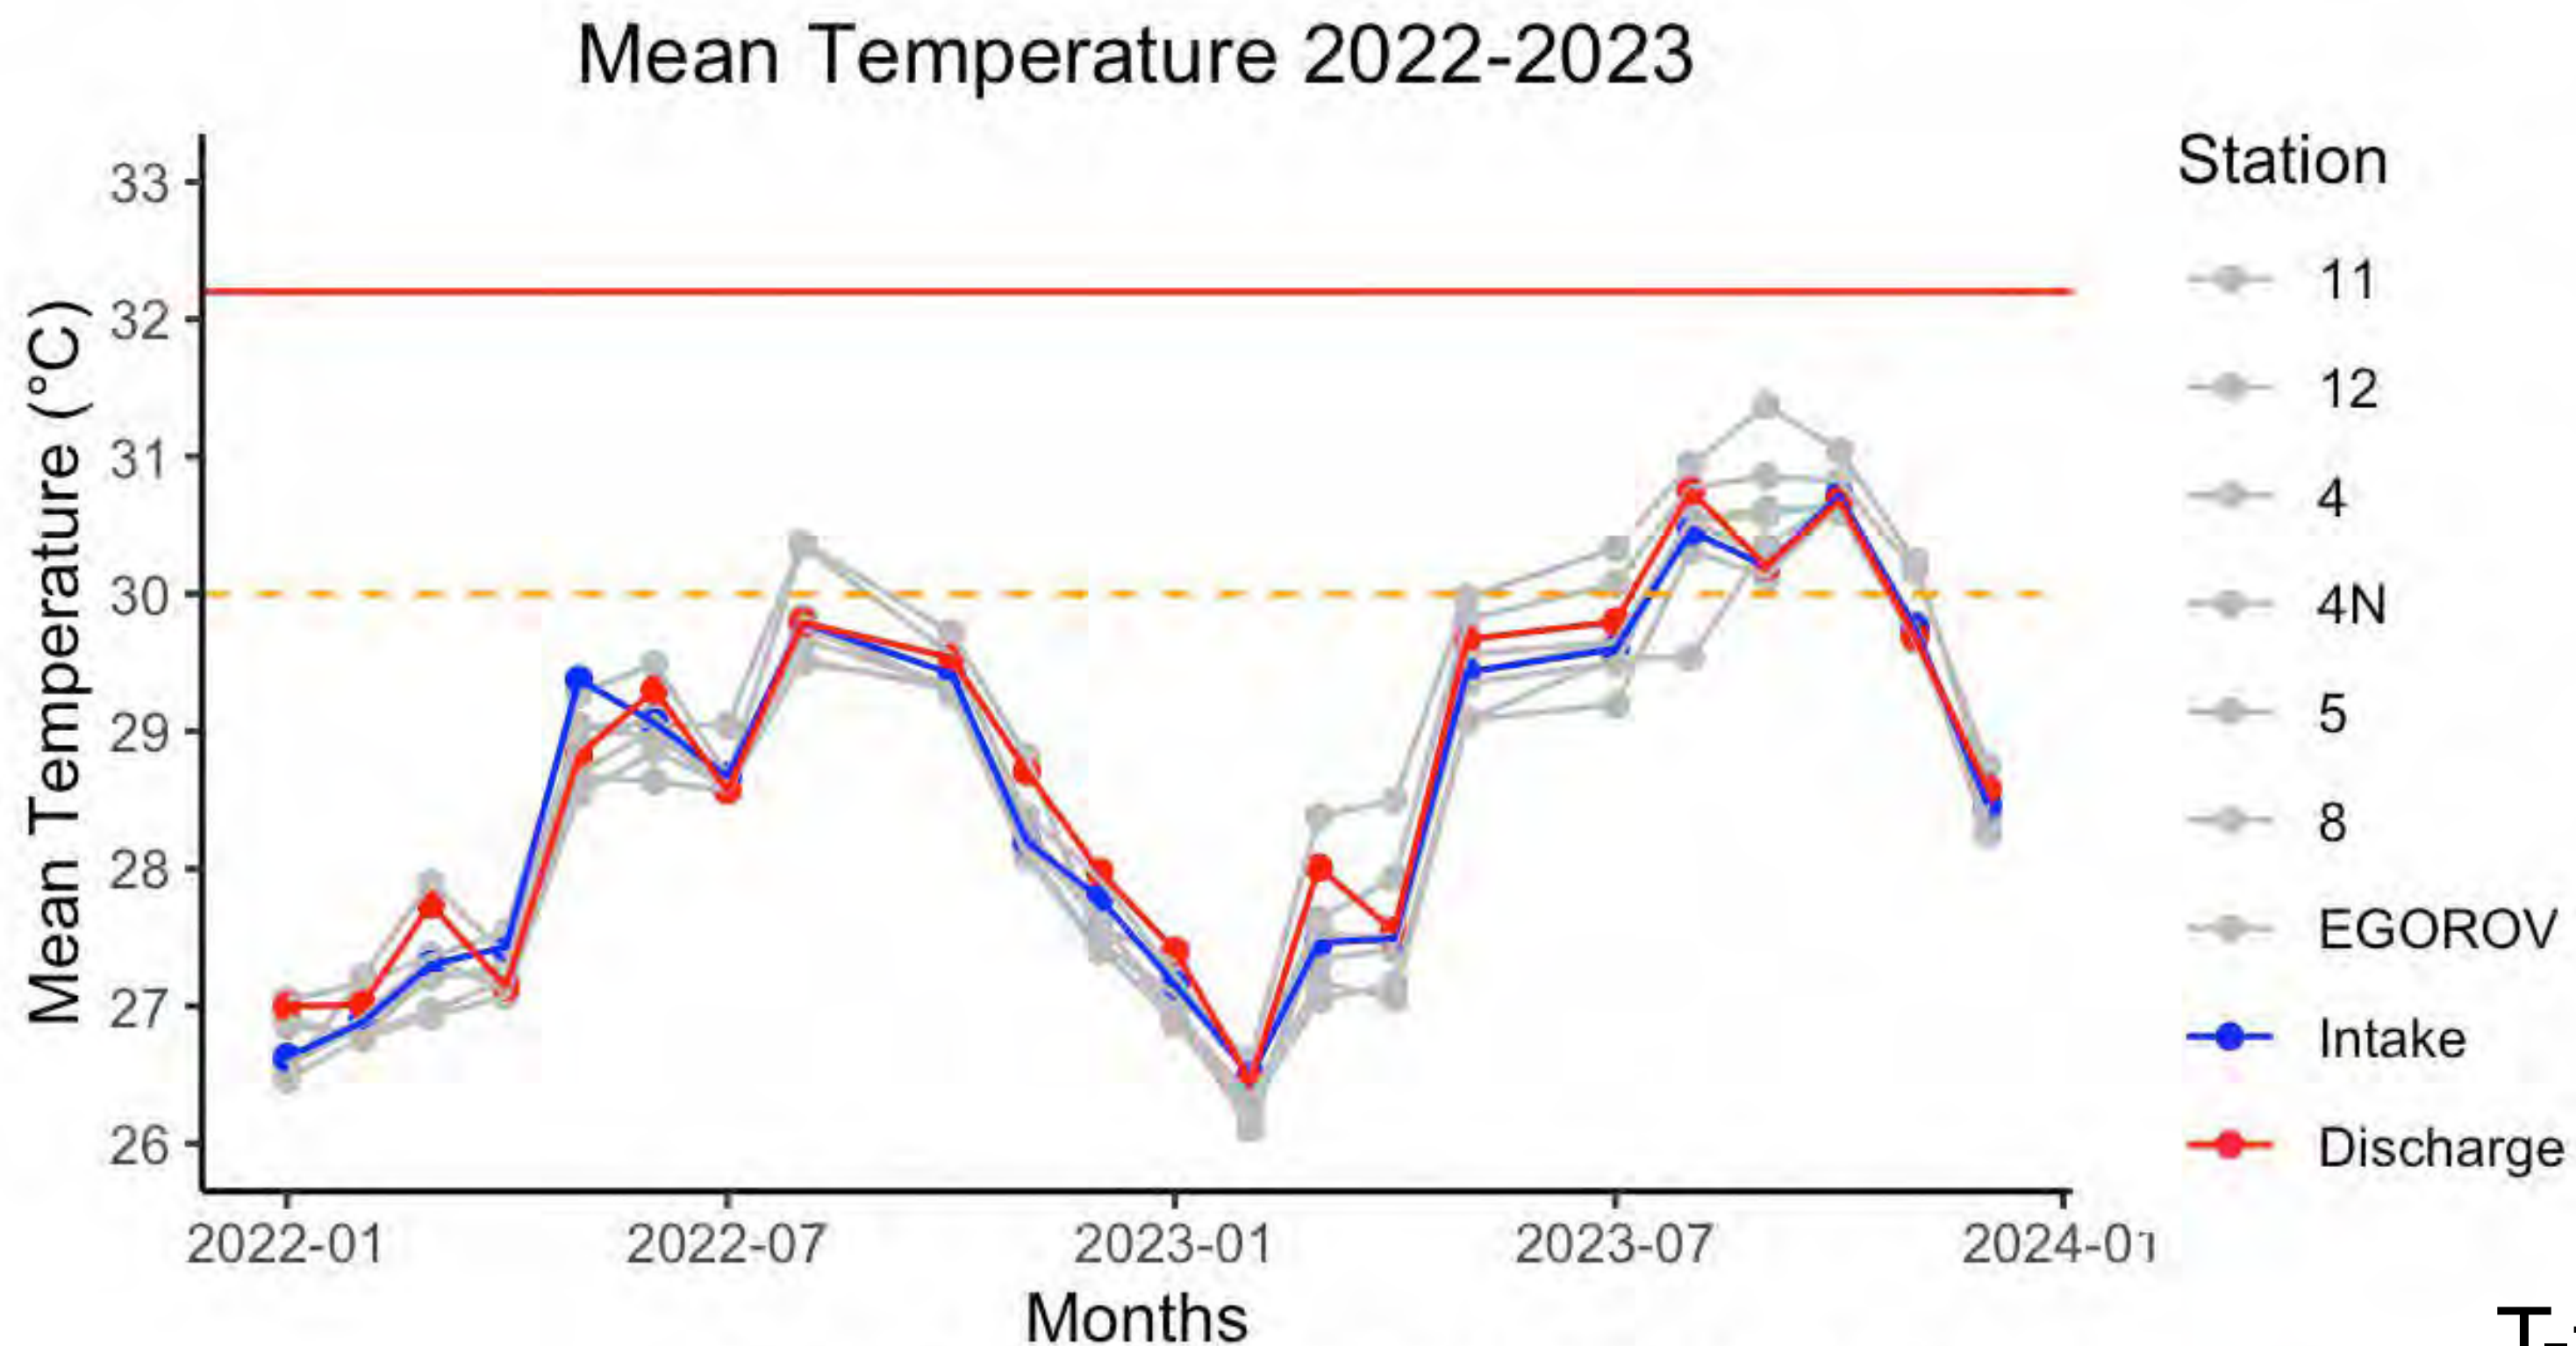
# Monthly Monitoring- Temperature

Data collected from monthly CTD (CastAway) sampling

T-test

p-value = 0.763

- An overall well mixed vertical distribution was observed.
- 0.9°C higher 2023 vs. 2022 (0.6°C higher in 2020!)
- No statistical difference found within stations during monthly monitoring.

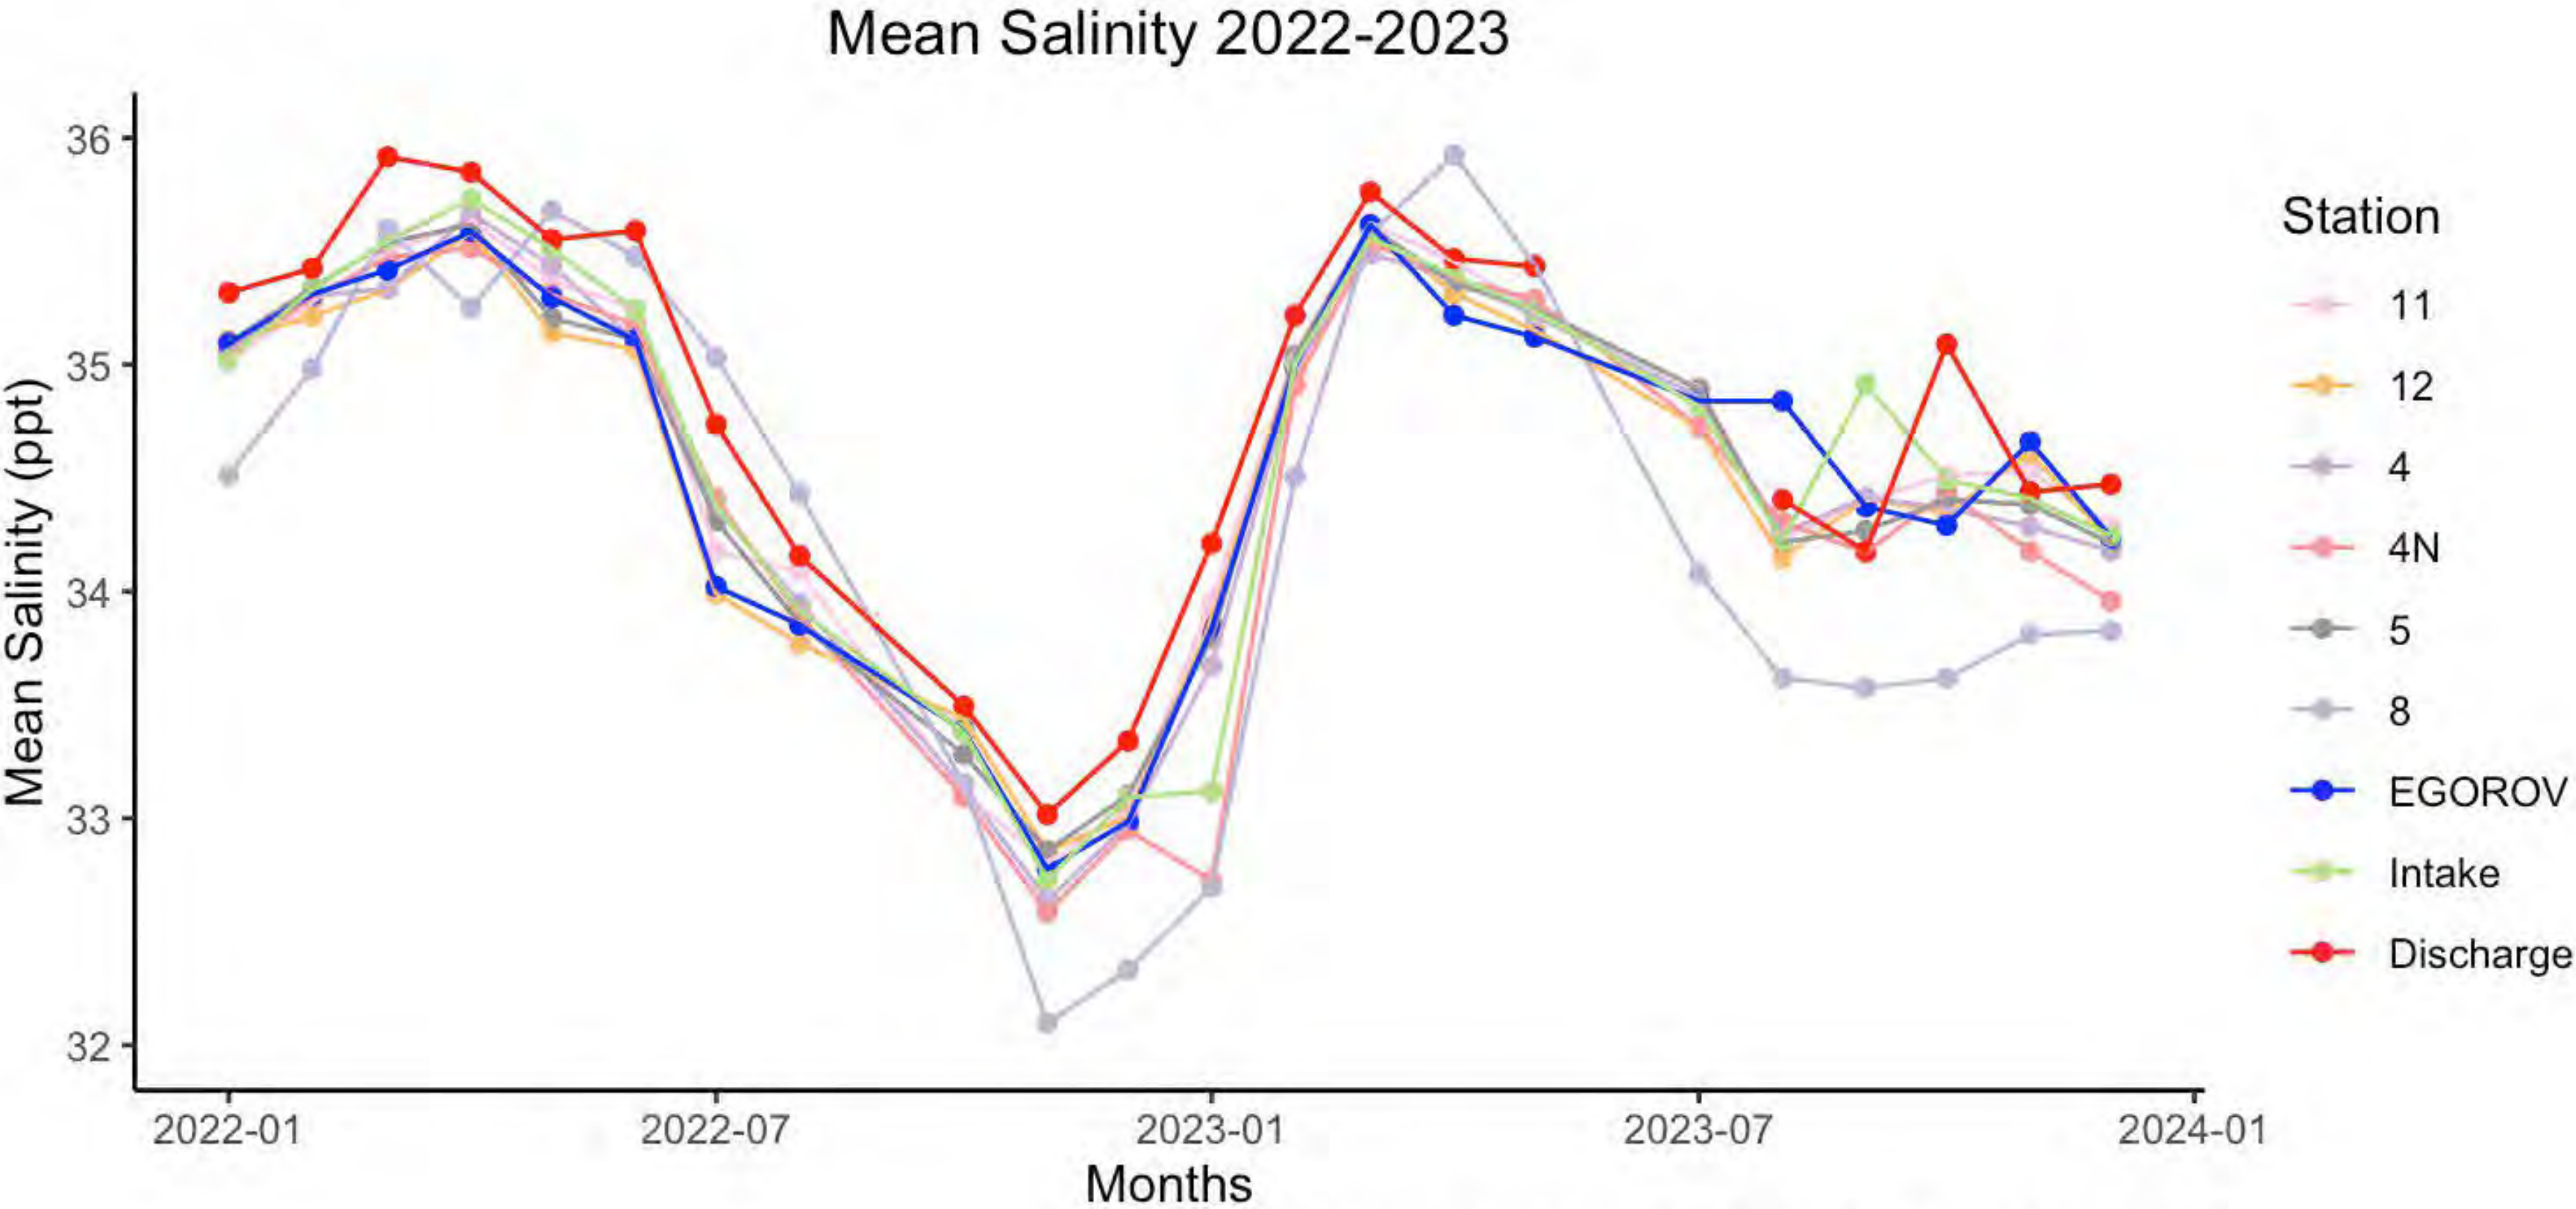
# Monthly Monitoring- Salinity

Data collected from monthly CTD (CastAway) sampling

- Same trend throughout all stations .

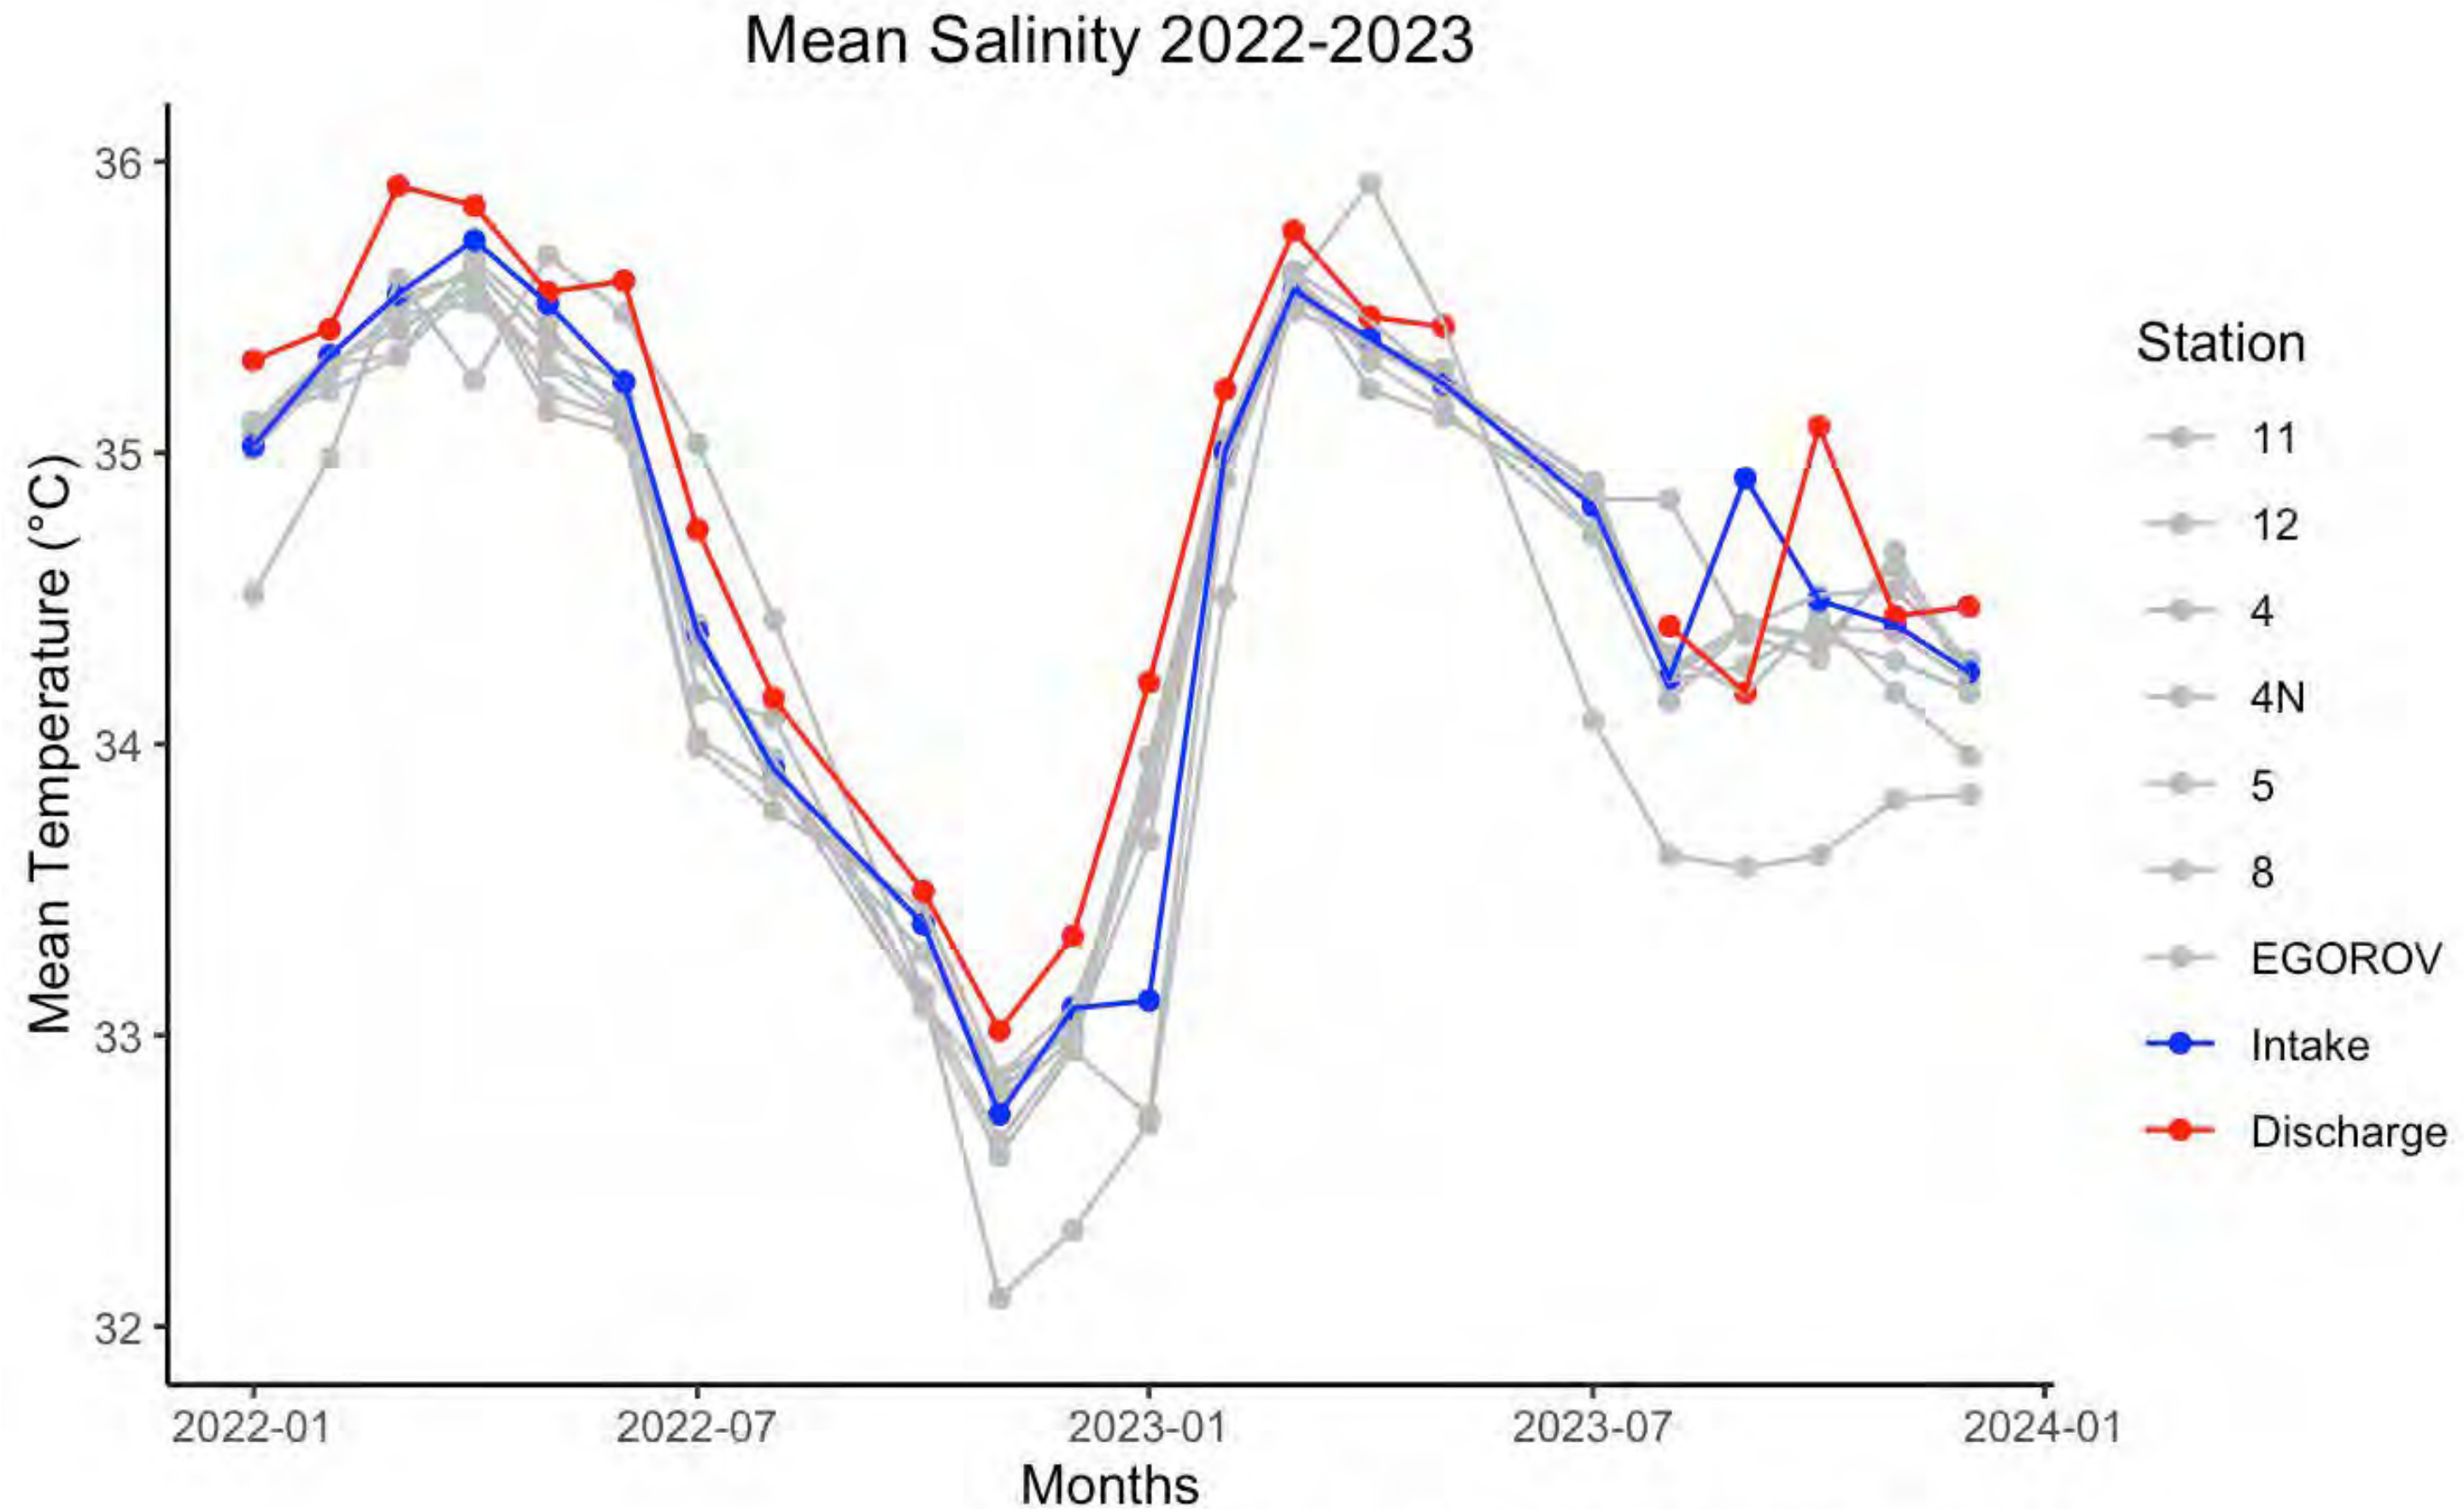
# Monthly Monitoring- Salinity

Data collected from monthly CTD (CastAway) sampling

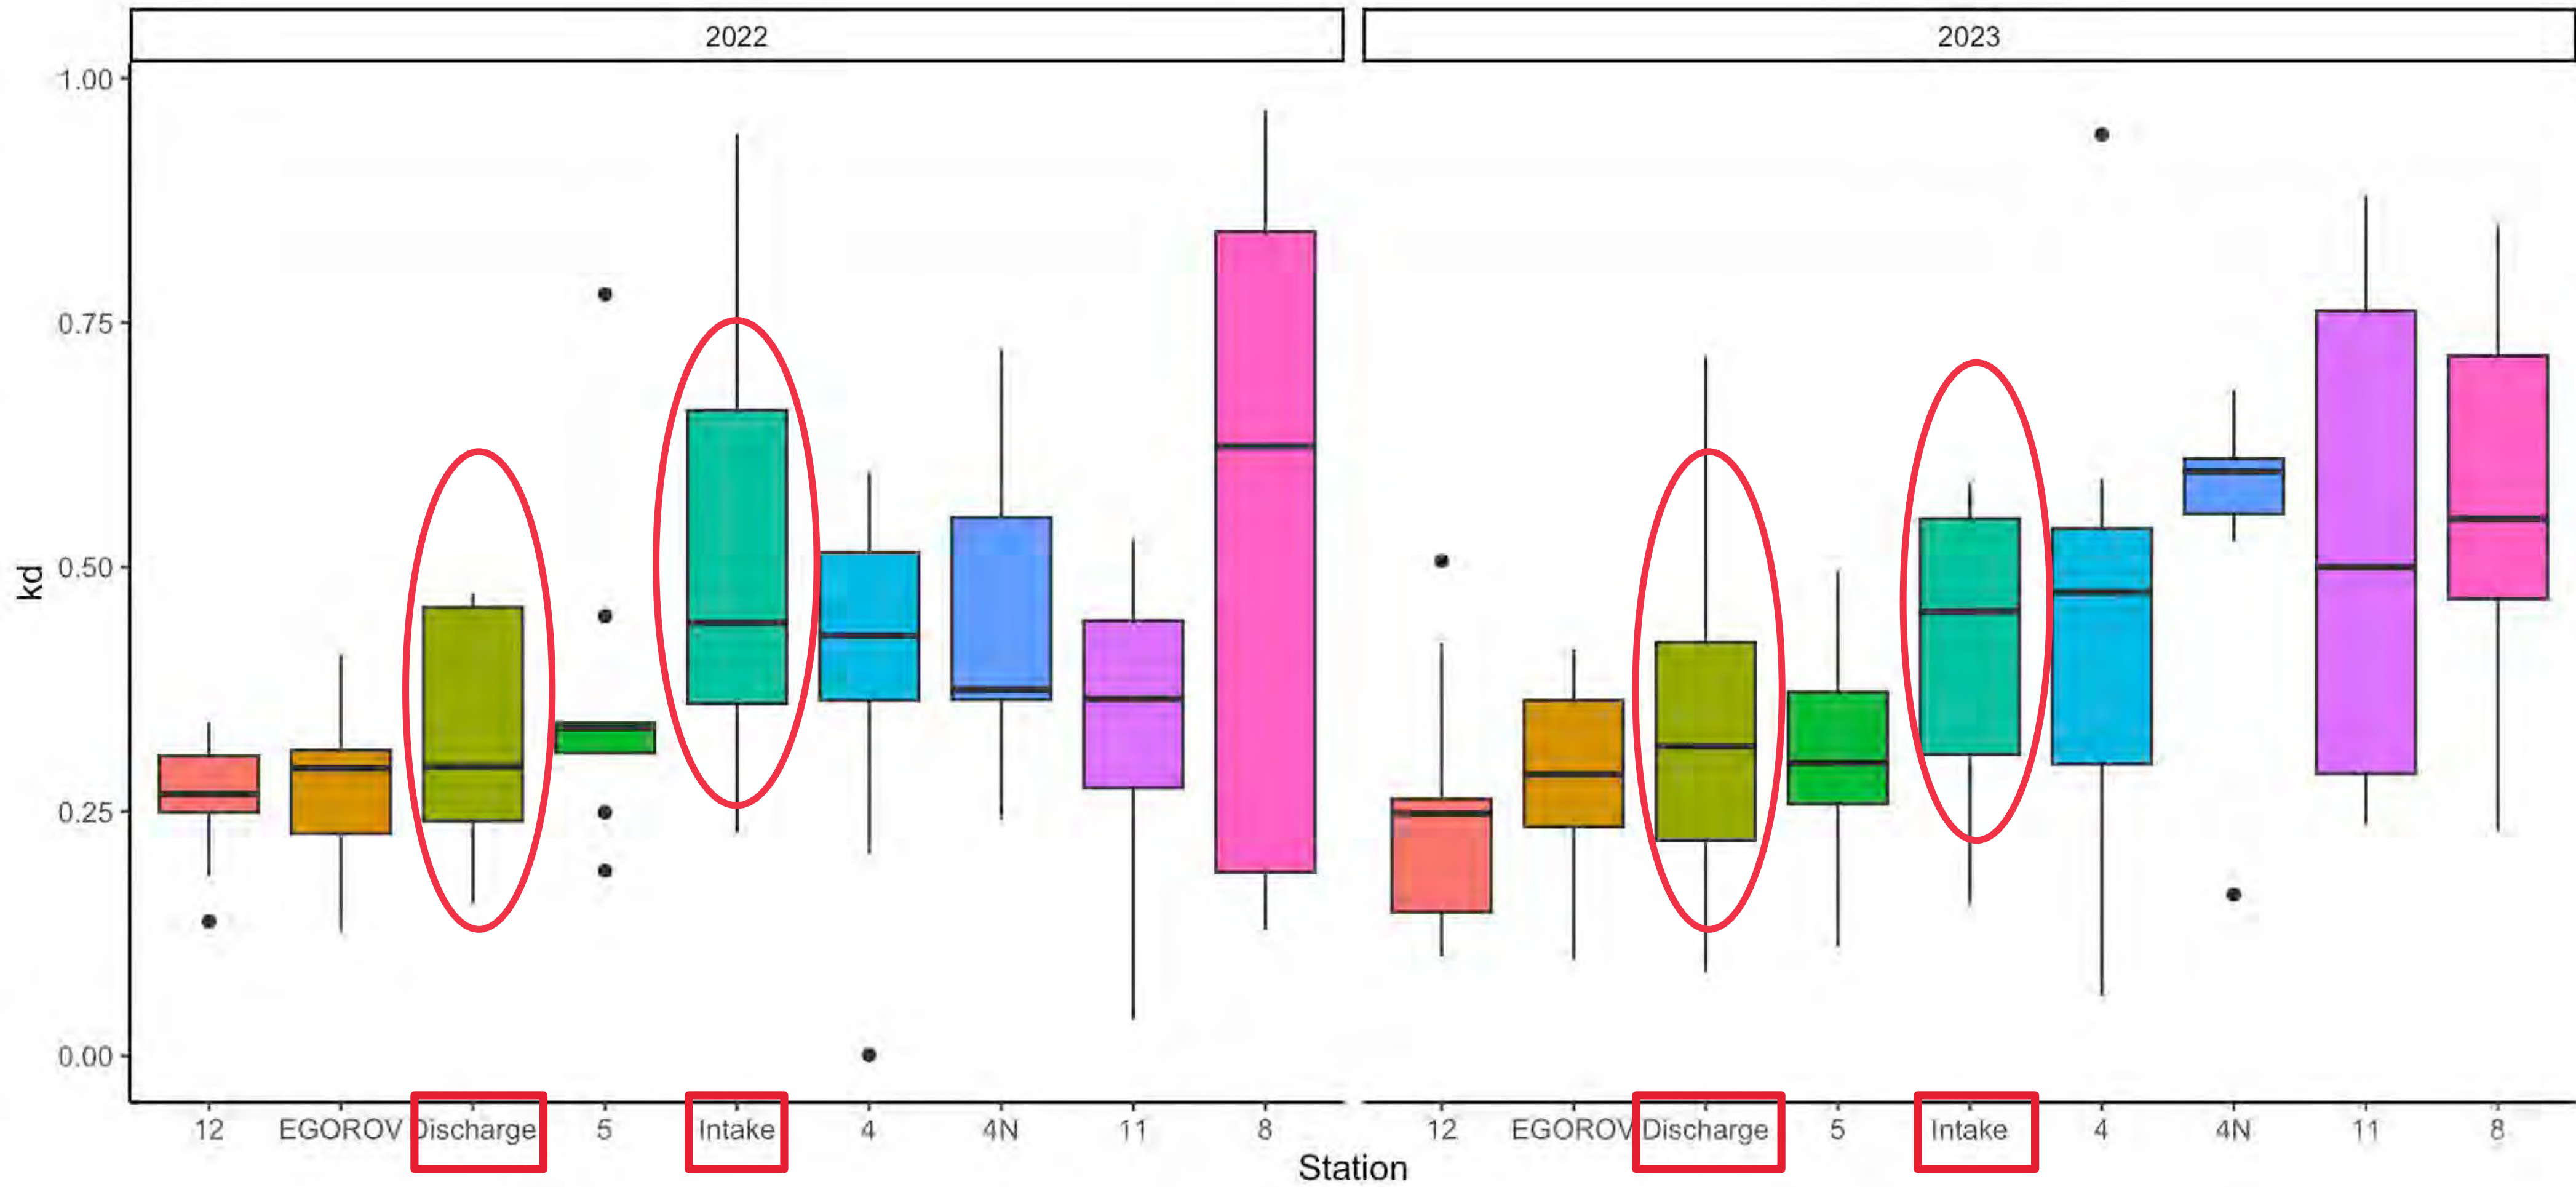
# Monthly Monitoring- Photosynthetically Active Radiation (PAR)

- Within established parameters .

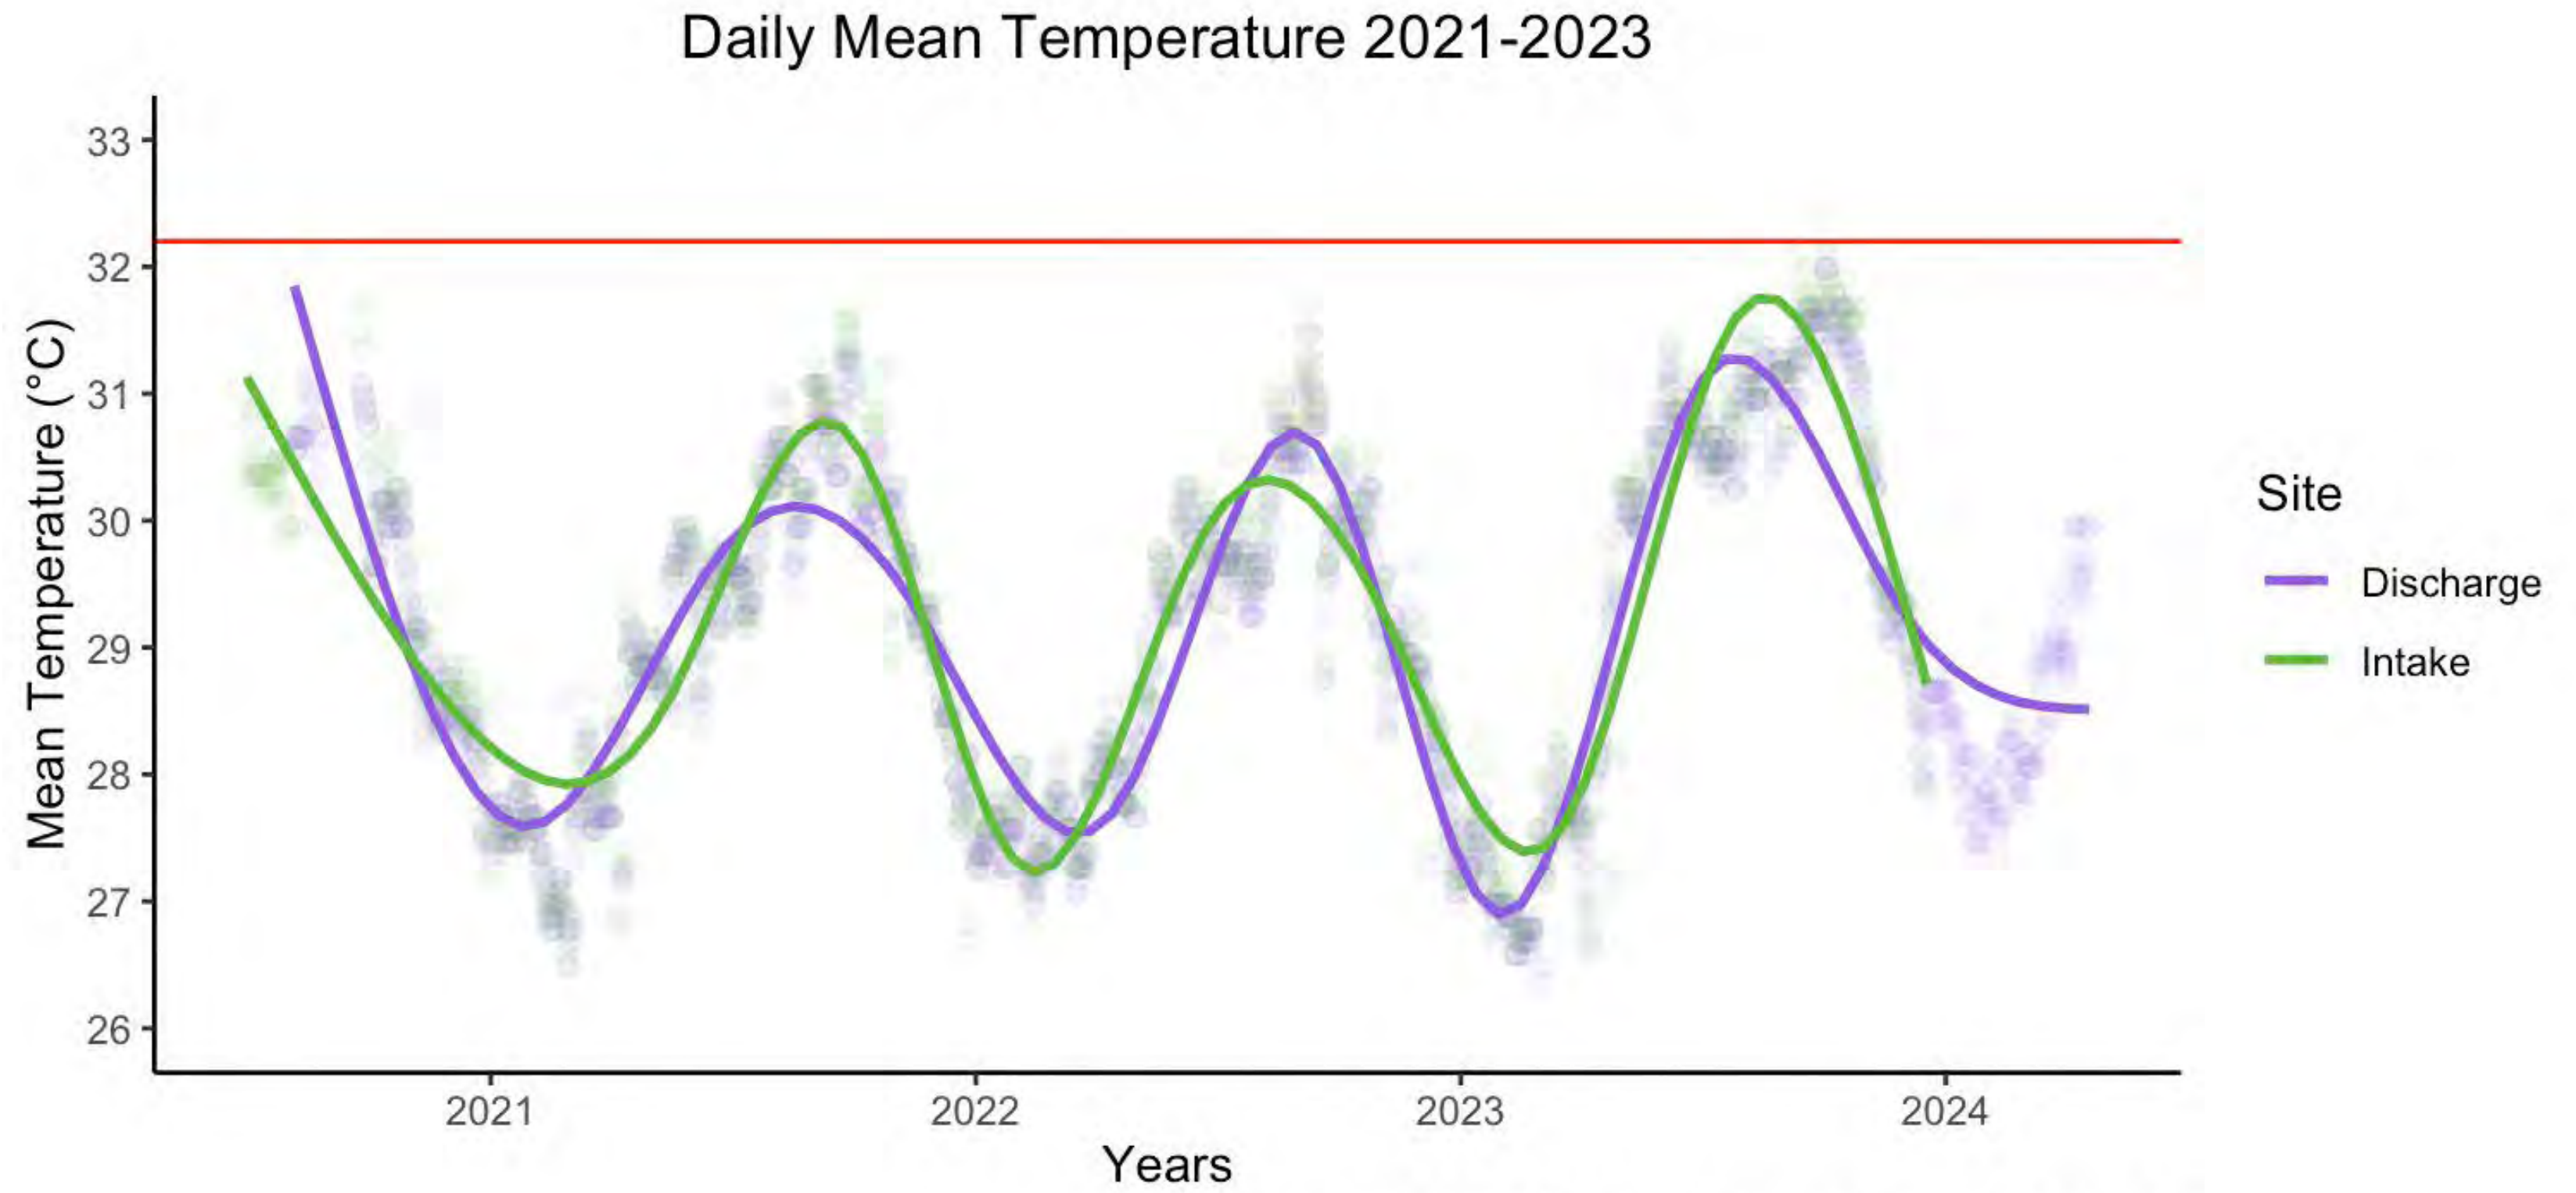
# Continuous Temperature: Intake and Discharge

Data collected from HOBO'S Daily sampling provided by HJR

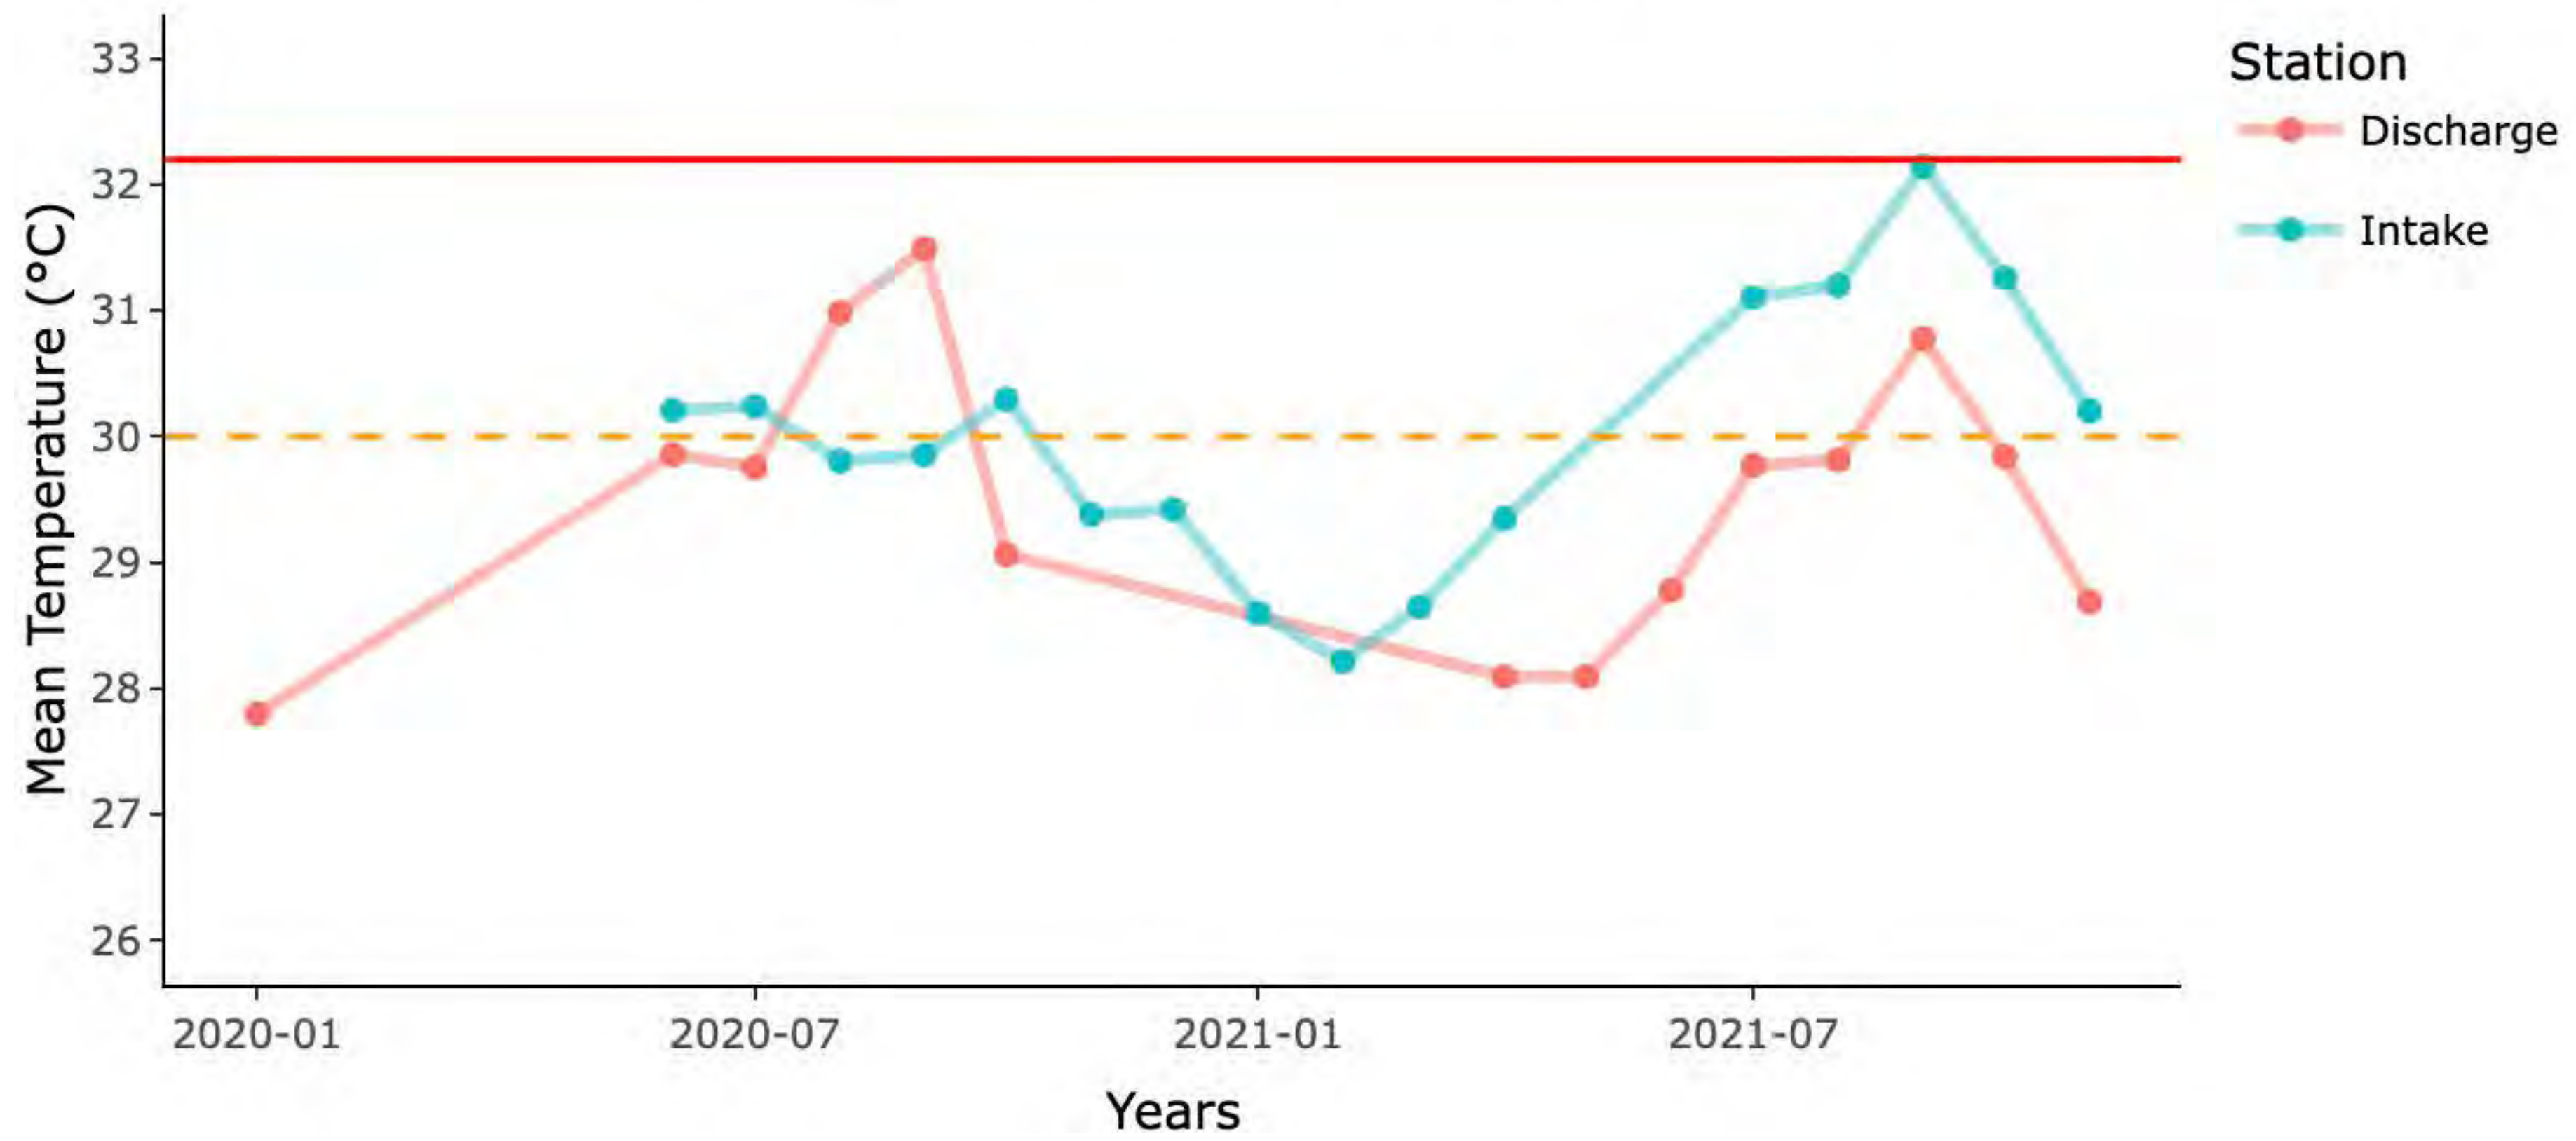
# Continuous Temperature: Intake and Discharge

Mean Temperature 2020-2021
